Failing to wear a seatbelt whilst operating mobile plant

Not wearing a seatbelt on mobile plant caused driver's head to hit windscreen.

LOCATION: QUARRY
ACTIVITY: TRANSPORT & LOGISTICS / DELIVERY
SUB ACTIVITY: MOBILE PLANT

ALERT STATUS: Normal
DATE ISSUED: 07/09/2018 15:10:16
INCIDENT No: 01495

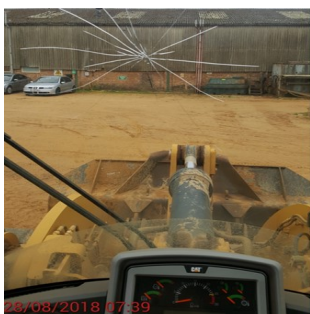
A front loading shovel driver was banging out a bucket whilst travelling up a ramp. As the bucket tipped forward it dug into the ramp causing the loading shovel to stop suddenly. The sudden stop caused the driver to be flung forwards. However, as he was not wearing a seatbelt, his momentum was not checked and his head hit the windscreen.

Crack on windscreen caused by impact with head

- Seatbelts are part of the overall safety system for a mobile plant to protect people from harm if the vehicle stops suddenly or overturns
- Seatbelts only work if they are worn correctly
- It is against the law for anyone to interfere or misuse anything provided in the interest of health and safety

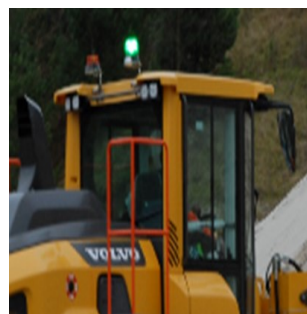
A review of the incident established that to override the seatbelt safety system, the seatbelt had been placed in the clip and the seatbelt placed behind the driver.

Green light on cab to indicate seatbelt is being worn
