# Fatal 6 - Isolator safety device failure

### Isolator could be turned on with castell system engaged

ALERT STATUS: Normal  
DATE ISSUED: 06/08/2019 17:28:36  
INCIDENT No: 01520

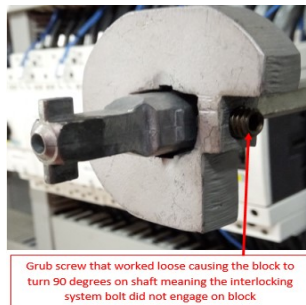
The potential for an operator to be injured existed when the mechanical locking system failed on the isolator switch for the mixer castell system. Although the operator had turned and removed the castell keys which should have locked the isolator in the 'Off' position. He discovered when implementing the 'Try Out' part of the LOTOTO system, the isolator could be turned back to the 'On' position.

An examination revealed that the block the castell key bolt should have engaged with had worked loose and turned 90 degrees. This meant that the bolt was not engaged in the recess of the block, this enabled the isolator to be moved with the keys out. The isolator switch locates on end of shaft. Block should turn with shaft if grub screw is done up correctly. See image

- All similar systems should be checked by competent person to ensure blocks are in correct position, grub screws are tight and blocks cannot move on the shaft.
- Isolators should be locked off with padlocks even if connected to an interlocking system
- Always check the isolator cannot be turned on as part of the 'Try Out' section of the LOTOTO system

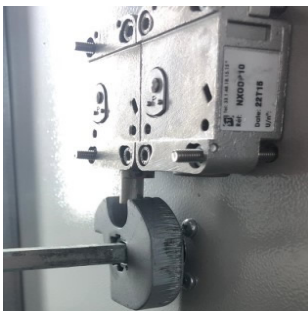
Please see images below of block with castell bolt located correctly in the top and isolator switch in off position with padlock attached.
