# Fatal 6 - Isolator safety device failure

### Isolator could be turned on with castell system engaged

**ALERT STATUS:** Normal  
**DATE ISSUED:** 06/08/2019 17:28:36  
**INCIDENT No:** 01520

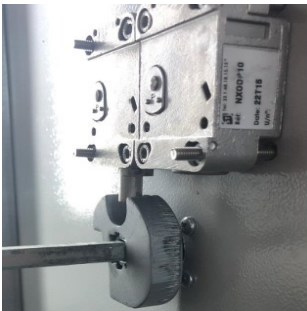
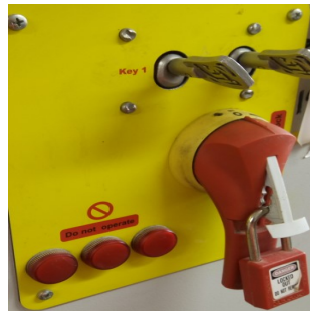
Please see images below of block with castell bolt located correctly in the top and isolator switch in off position with padlock attached.

- All similar systems should be checked by competent person to ensure blocks are in correct position, grub screws are tight and blocks cannot move on the shaft.
- Isolators should be locked off with padlocks even if connected to an interlocking system
- Always check the isolator cannot be turned on as part of the 'Try Out' section of the LOTOTO system
