'The Fatal 6' - Struck by Moving/Falling Object - Falling Tool

LOCATION:	CEMENT PLANT	ALERT STATUS:	Normal
ACTIVITY:	MAINTENANCE & HOUSEKEEPING	DATE ISSUED:	11/02/2020 10:41:45
SUB ACTIVITY:	N/A	INCIDENT No:	01548

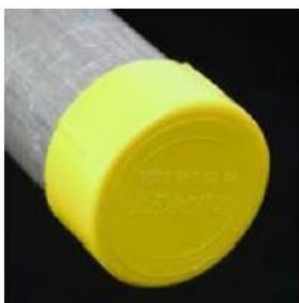
Best practice is to cap all horizontal scaffolding tubes where known personnel may be working. The use of these end caps reduces the likelihood of items being placed into an open end tube.

End Cap
