# Over-Turned Vibratory Roller

## WHAT HAPPENED

**ALERT STATUS:** **Normal**  
**DATE ISSUED:** **31/03/2011**  
**INCIDENT No:** **00286**

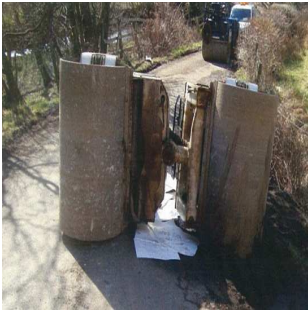
Overturned Roller 1

During routine site operations ; a Bomag 135 (small tandem vibratory roller) was being driven along a small country lane to collect water from a standpipe. The lane was narrow, cambered and with steep undulations, there was also an area of super elevation.

As the roller was being driven along one of these super elevated sections, one of the rolls lost contact with the road surface causing it to traverse down the lane. As it did so, it began gathering soil from the verge into the rear drum - to such an extent that it over turned the machine - with the operator still on board.

The operator was saved from serious injury due to two key safety devices.

- the seat belt prevented him from falling from the seat and underneath the roller.
- the ROPS (Roll Over Protection System) was in place protecting the machine from rolling completely over and protected the operators upper body and head.

ALWAYS WEAR YOUR SEAT BELT - ENSURE IT IS FUNCTIONAL

CHECK THE ROPS STRUCTURE DAILY - ENSURE IT IS FIXED IN POSITION - NO DEFECTS

SURVEY TRAVEL ROUTES PRIOR TO EMBARKING WHENEVER POSSIBLE

KEEP YOUR TRAVEL SPEED LOW ENOUGH FOR YOU TO REACT TO UNEXPECTED SITUATIONS

REPORT DEFECTS IMMEDIATELY
