Articulated Dumper Cab Overturn

WHAT HAPPENED

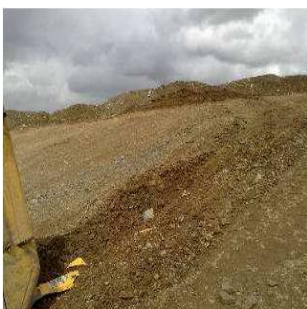
Slope

Whilst attempting to reverse down the slope the driver had his cab angled at 90 degrees to the trailer section which was positioned down the slope. Due to the width of the flat area at the top of the slope and the area being driven and turned on several times, depressions had appeared.

The front left hand side wheels were just off the flat area and on to the slope. The front left wheel went into a depression causing the cab to dip, due to this the weight of the rear body and its load caused the rear to drag the cab over and then slide approx 6 metres down the slope.

- the tip area being a more suitable grade for the operation and the operation better planned
- a more stringent inspection regime of the tip area by site managers, supervisors and drivers

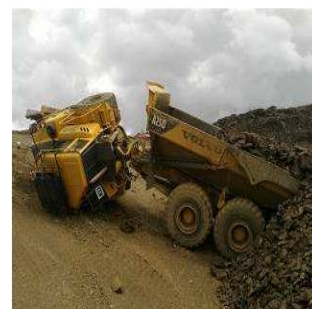
Overturned Cab

An Articulated dumper cab turned over whilst attempting to reverse down a slope with the cab at 90 degrees to the rear body. The driver suffered bruising to his right thigh and was prevented from further injury as he was wearing his seatbelt.
