The Value Of Well Maintained Safety Devices

LOCATION: QUARRY
ACTIVITY: TRANSPORT & LOGISTICS / DELIVERY
SUB ACTIVITY: MOBILE PLANT

ALERT STATUS: Normal
DATE ISSUED: 19/08/2011
INCIDENT No: 00304

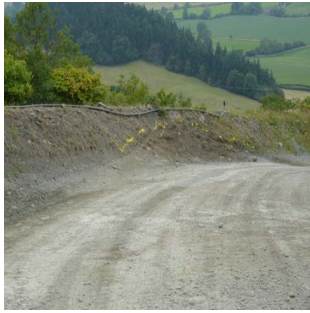
While working on a muckshift operation a contractors dumper lost control while descending a steep section of haul road. The dumper ran up the haul road edge protection bunds a number of times and in each case the bund did exactly what it was designed to do in steering the dumper back on to the haul road.

Yellow Paint Highlights Outer Wheel Path

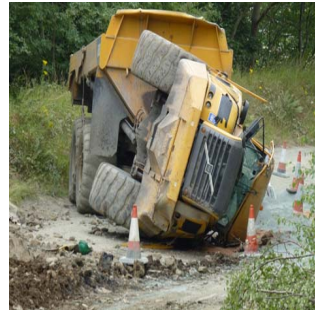
Unfortunately the driver was unable to regain control and the dumper eventually jack knifed causing the front of the dumper to rotate through 270 degrees and the whole vehicle came to rest facing back up the hill down which it had just descended. Despite this the driver freed himself from the vehicle.

Dumper at Rest
