## Fatal Incident - Cyclist

**ALERT STATUS:** High Potential  
DATE ISSUED: 12/07/2012  
INCIDENT No: 00335

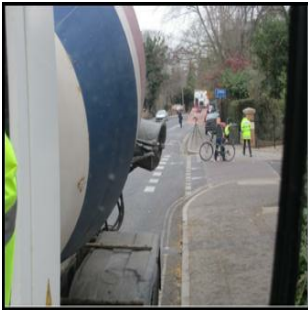
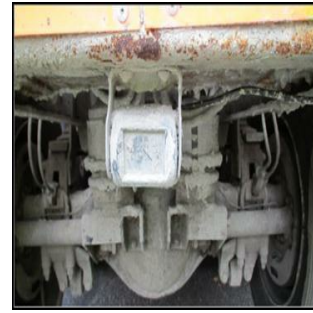
A young female cyclist was fatally injured at a T-junction when she was struck by a truck mixer that was being driven by a contract driver. The following is based on the police reconstruction of the incident and may change should further evidence become available. The driver of the truck was travelling along a main road and wanted to turn his vehicle around and travel back the way he had come; the road is two way with single opposing carriageways. As he passed the junction, the driver moved over into the opposite carriageway, facing the oncoming traffic, and reversed into a side road. It is believed witnesses to the incident saw the cyclist in the centre of the side road, waiting to turn onto the main road at the T-junction. As the driver exited back onto the main road, it seems the front nearside of the truck struck the cyclist, despite the efforts of one witnesses to alert him to the danger. The driver was arrested at the scene and has been charged with “causing death by careless driving”.
