Cardox shells – which involve an explosive discharge of compressed carbon dioxide – is frequently used to dislodge build up in the Cement Plant calciner to restore normal operating conditions.

THE INCIDENT

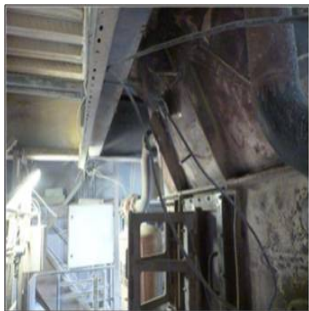
Charged cardox shells are inserted into a previously drilled hole in the side of the calciner.

The shells are retained in place by means of a

collar that is secured by a one quarter turn into a threaded opening in the wall of the calciner.

The shell has a slightly raised shoulder at one end which has a larger external diameter than the internal diameter of the centre of the collar. This prevents the shell from being ejected from the calciner when detonated – provided that the correctly sized collar is used.

The shell is “detonated” by an electric charge activating a heater unit in one end of the shell which instantaneously vaporises the carbon dioxide which explosively discharges through a bursting disc at the opposite end, breaking away build up.
