Operator injures foot while replacing the cutting edge on loading shovel bucket

ALERT STATUS: Normal
DATE ISSUED: 23/02/2021 20:21:41
INCIDENT No: 03587

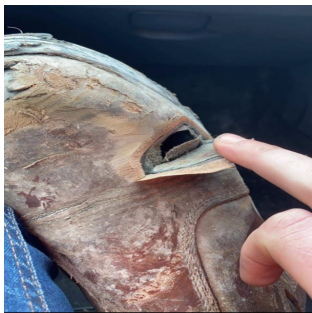
A trained operative was changing a cutting edge on a loading shovel bucket. The old edge had been removed and the base edge cleaned with a scraper (as per safe operating practice). Before fitting the new edge, the operative noticed some dirt remaining on the base edge and raised his foot to rub it off. The base edge was worn sharp like a razor and sliced through his safety boot, above the steel toecap and sliced the operative's foot. The operative required a trip to A&E and the wound required stitching. This resulted in a LOST TIME INJURY (LTI) as the operative was required to rest his foot to ease pressure on the stitches.

Damage to the boot above toe cap

Once the old cutting edge is removed, be aware that the base edge of a worn bucket can be very sharp NEVER run your hand or foot along the edge ALWAYS use a scraper or brush to clean the underside of the bucket, prior to fitting the new cutting edge.
