Fatal 6 -Transport - Serious RTA and a tipper rollover

ALERT STATUS: Normal
DATE ISSUED: 04/05/2023 17:39:41
INCIDENT No: 03638

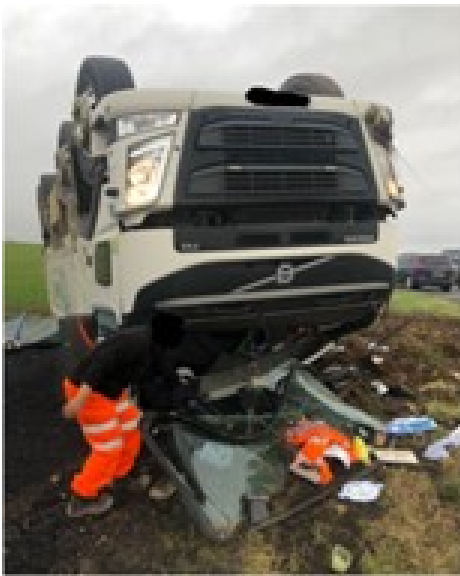
- The HGV driver was relatively inexperienced.
- The driver had moved to the nearside to ensure it did not make wing mirror contact with the other oncoming HGV. In doing so the nearside tyres went on a soft grass verge.
- The driver corrected this but quickly went across the other carriage way and onto the soft grass verge/bank that sloped away causing the tipper to roll over onto its roof.
- The driver was not hurt because they were wearing their seatbelt and had securely stored items within the cab.

- Drivers to take extra caution in poor weather especially when crossing high speed network carriageways in the fog, use vehicle lights in poor visibility and ensure conspicuity markings and tailboards are regularly cleaned.
- Drivers to be cautious of soft verges and take care not to overreact or over compensate.
- When driving expect the unexpected.
- Hauliers to remind their drivers of winter working driving hazards.
