Fatal 6 - Transport - Tipper caught on a railway level crossing

LOCATION:	ON-HIGHWAY	ALERT STATUS:	Normal
ACTIVITY:	TRANSPORT & LOGISTICS / DELIVERY	DATE ISSUED:	16/05/2023 16:21:44
SUB ACTIVITY:	DRIVER AWARENESS	INCIDENT No:	03639

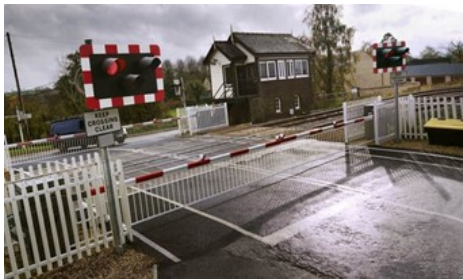
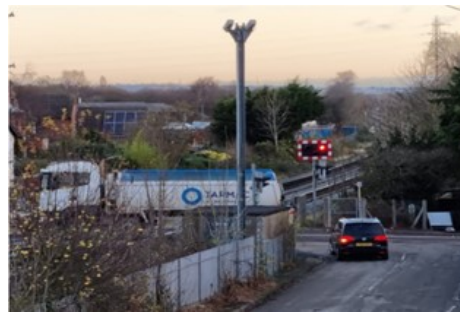
An independent contracted hauliers 8w rigid liveried tipper got caught between two closing railway barriers trapping the vehicle on the level crossings. On this occasion it was a monitored crossing, so the barriers were raised immediately, and any approaching train held, preventing a serious incident.

- The vehicle had just turned left 90 degrees out of a junction onto the crossing and was focused on traffic coming from both directions
- The barriers had just been lifted and closed again within 30 seconds. The driver did not expect the barriers to close again so quickly
- The driver was experienced, under no pressure and had a good safety and driving record
- The exit of the crossing was not blocked
- The driver correctly exited his cab when he got caught on the crossing but immediately returned to the vehicle and cleared the crossing upon seeing the barriers start to rise again

- The safe and legal operation of the vehicle remains solely with the driver at all times, and they should ensure it is safe to enter a level crossing
- Drivers should ensure that their exit is clear before starting to cross the crossing and not to attempt to cross if the warning lights are flashing
- Drivers must remain vigilant and ensure that the highway regulations are being observed and that there is no danger presented to other vehicles and pedestrians
- Hauliers to report any such incidents to the company for whom they are working
