Transport - Driver suffers asphalt burns to hands

LOCATION: ASPHALT/COATING PLANT
ACTIVITY: TRANSPORT & LOGISTICS / DELIVERY
SUB ACTIVITY: DELIVERING ASPHALT & HOT BOXES

ALERT STATUS: Normal
DATE ISSUED: 03/07/2023 12:40:16
INCIDENT No: 03649

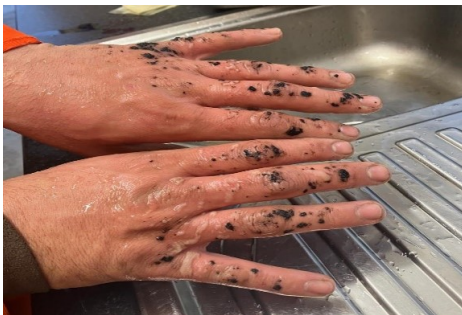
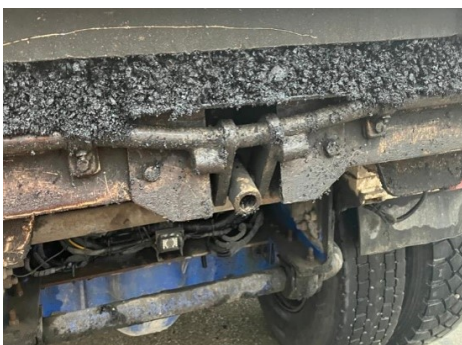
A contract tipper vehicle was overloaded with asphalt and the driver had to tip off a small amount in the designated area. After doing so, the rear door was prevented from closing by product loaded towards the back of the vehicle body. The driver used a tool / bar, which should only be used to open the tailgate if it fails to open automatically, to try and force the tailgate shut; the bar slipped and his hands momentarily came into contact with the hot asphalt below. First aid was administered on site and the driver went to hospital later in the day. He was able to carry out restricted duties the next day and returned to full driving a few days later.

- The overloading of the vehicle wasn't an isolated incident.
- The driver self loaded the material too close to the tailgate.
- The tip-off area is located in a busy part of the site, with limited space for the driver to move the vehicle forward after discharging the materials on to the floor.
- This particular vehicle had an unusual / bespoke tailgate and the driver used a tool / bar that wasn't suitable.
- The driver was not wearing gloves during this activity.
- The quick actions of the site staff to administer first aid reduced the severity of the driver's injuries.

Image above shows where driver inserted tool to try and close tailgate

- Vehicles are not overloaded and product isn't sitting against the tailgate.
- Ensure people are trained and competent to operate equipment.
- Wear gloves for all manual activities.
- Ensure safe systems of work are in place to include activities such as this
