TRANSPORT - Fatal 5 - Operator injured when strap snapped and recoiled striking the operator on the ankle

LOCATION:	RAILHEAD	ALERT STATUS:	Normal
ACTIVITY:	TRANSPORT & LOGISTICS / DELIVERY	DATE ISSUED:	10/10/2023 11:06:59
SUB ACTIVITY:	DELIVERING CEMENT	INCIDENT No:	03671

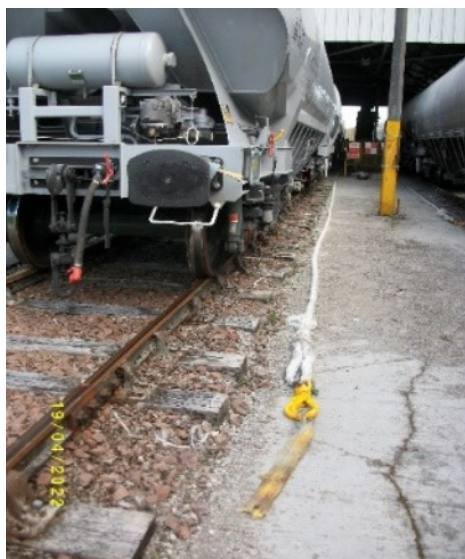
Image shows broken strap attached to buffer.

- Site stopped using JGA wagons at the location where incident occurred
- Safety brief to be conducted to all personnel including any contractors regarding the safe zone.
- A visual safe zone to be painted on the floor to make personnel aware of the safe zone area.
- HIRA and SSoW to be updated to include more detail and communicated to all person involved in the task, include contractors via induction.
- Identify any lifting and other equipment which has not registered to the site and inspect/service remove/dispose.
- A management of change to be conducted if the use of JGA wagons is decided to restart.

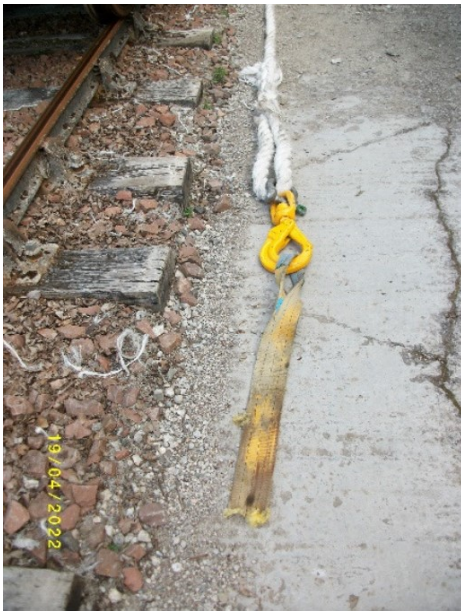
Images show broken strap and rope

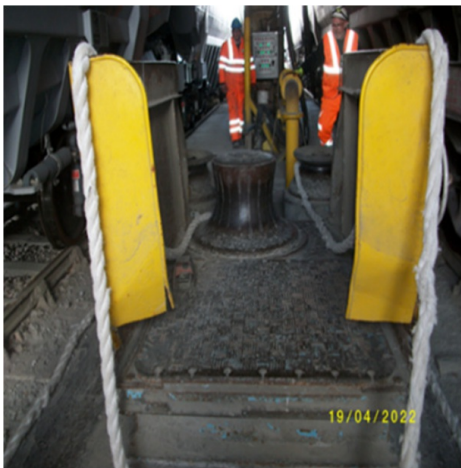
Rope and capstan
