TRANSPORT - Fatal 5 - Operator injured when strap snapped and recoiled striking the operator on the ankle

LOCATION:	RAILHEAD	ALERT STATUS:	Normal
ACTIVITY:	TRANSPORT & LOGISTICS / DELIVERY	DATE ISSUED:	10/10/2023 11:06:59
SUB ACTIVITY:	DELIVERING CEMENT	INCIDENT No:	03671

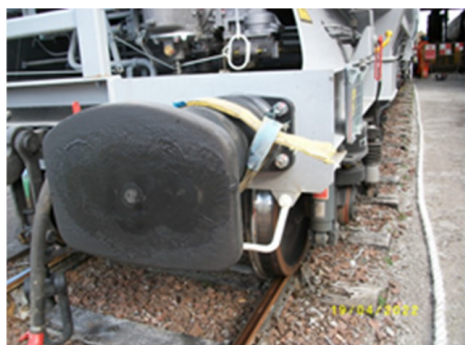
Image shows broken strap attached to buffer.

- Site stopped using JGA wagons at the location where incident occurred
- Safety brief to be conducted to all personnel including any contractors regarding the safe zone.
- A visual safe zone to be painted on the floor to make personnel aware of the safe zone area.
- HIRA and SSoW to be updated to include more detail and communicated to all person involved in the task, include contractors via induction.
- Identify any lifting and other equipment which has not registered to the site and inspect/service remove/dispose.
- A management of change to be conducted if the use of JGA wagons is decided to restart.

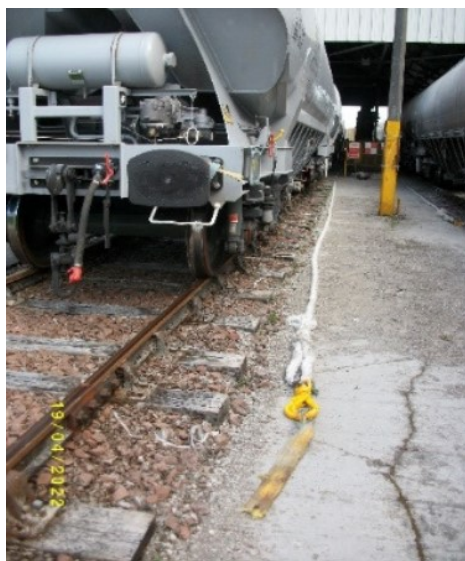
Images show broken strap and rope
