# Fatal 5 - A hammer falling 10 metres narrowly misses a team of workers.

**LOCATION:** CEMENT PLANT  
**ACTIVITY:** MAINTENANCE & HOUSEKEEPING  
**SUB ACTIVITY:** KILNS

**ALERT STATUS:** Normal  
**DATE ISSUED:** 10/10/2023 12:09:21  
**INCIDENT No:** 03672

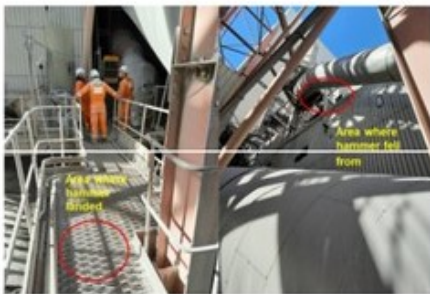
A report was made that a hammer had fallen approximately 10 meters onto the electrostatic precipitator gantry. A scaffolding contractor stated the hammer landed approximately 3 meters from where the team were standing. They were unsure of where exactly the hammer had fallen, however following further investigation it was established that the hammer had fallen from the area highlighted in the image below.

- No injury was sustained from the falling object.
- People had been working in the area from where the hammer is believed to have fallen from.
- An employee who was carrying out housekeeping duties reported their hammer missing around the same time as this incident was reported.
- An unsecured or poorly stored tool "hammer" has come off the edge of a platform and fallen during the housekeeping activity

- Stand sites down and issue a TBT/briefing highlighting the requirement to use good methods of equipment storage, transportation, and tethering.
- Consideration to be given to include tool storage in future inductions.
