TRANSPORT - Cement tanker remaining partially pressurised after delivery

LOCATION:	READYMIX OR MORTAR PLANT	ALERT STATUS:	High Potential
ACTIVITY:	TRANSPORT & LOGISTICS / DELIVERY	DATE ISSUED:	23/07/2024 12:52:33
SUB ACTIVITY:	DELIVERING CEMENT	INCIDENT No:	03727

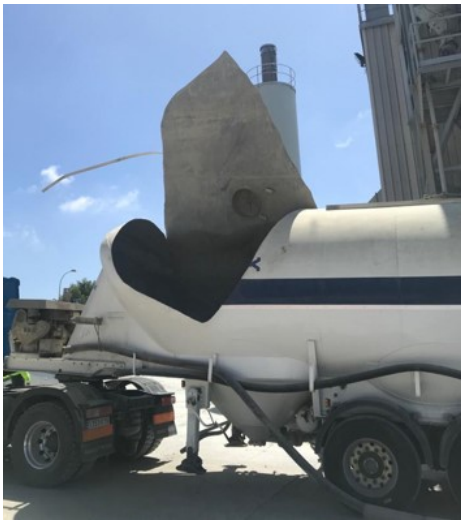
Whilst this is not a common occurrence, it also isn't an isolated incident and can result in a tank rupture, particularly when there may be a weak spot on the tank. The image below is an example of how a tank with a weak weld ruptured in 2020.

- Drivers must ensure tanks are fully de-pressurised after discharge by checking the pressure gauge returns to zero.
- Never drive a vehicle with a tank that still has pressure in it
- Never leave a site while a tank still has pressure in it
- Always check the saunders valve (a.k.a dump valve or daisy wheel) is fully open when finished and leave it open.
- Always check the saunders valve is fully open and tank depressurised before opening any lids to load.
