# TRANSPORT - Fatal 5 - Runaway - Asphalt hot box wagon in crash

**LOCATION:** ASPHALT/COATING PLANT  
**ACTIVITY:** TRANSPORT & LOGISTICS / DELIVERY  
**SUB ACTIVITY:** LOADING

**ALERT STATUS:** High Potential  
**DATE ISSUED:** 29/08/2024 14:24:44  
**INCIDENT No:** 03731

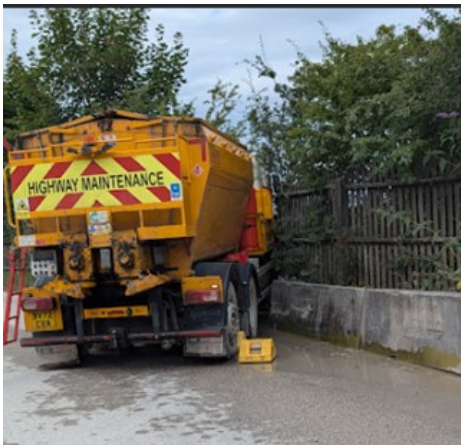
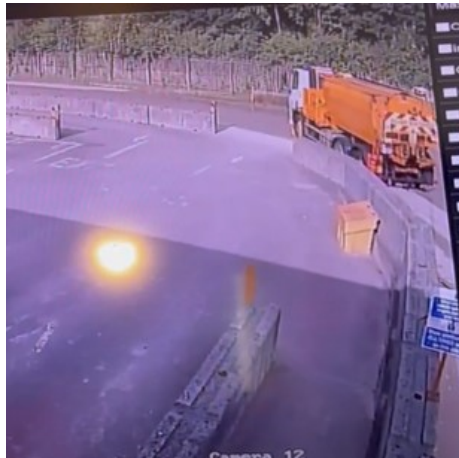
Initial investigations indicate that the third party hotbox wagon was loaded at the asphalt plant. The driver parked just beyond the designated sheeting area and failed to apply their parking brake. Whilst performing checks on the wagon prior to leaving the site the vehicle began to roll away.

The driver jumped down from the vehicle on the passenger side and ran in front of the moving vehicle to try and access the cab and stop the vehicle. The driver was unsuccessful in stopping the vehicle which came to rest after colliding with the boundary fence.

Images below show where the vehicle crashed into a barrier on-site and image caught by camera as the vehicle rolled away.

- Always park in the designated parking areas, where provided
- Always ensure parking brakes are applied before exiting the vehicle
- Avoid parking on a gradient, however if not possible, ensure the wheels are also chocked and vehicle is stable
- **DO NOT** put yourself in the line of fire
