Fatal 1 - Defective isolator on a Warrior 1400 Powerscreen and the importance of following LOTOTO process

LOCATION:	QUARRY	ALERT STATUS:	Normal
ACTIVITY:	GUARDING AND ISOLATION	DATE ISSUED:	19/09/2024 13:38:14
SUB ACTIVITY:	NO SUB ACTIVITY AVAILABLE	INCIDENT No:	04833

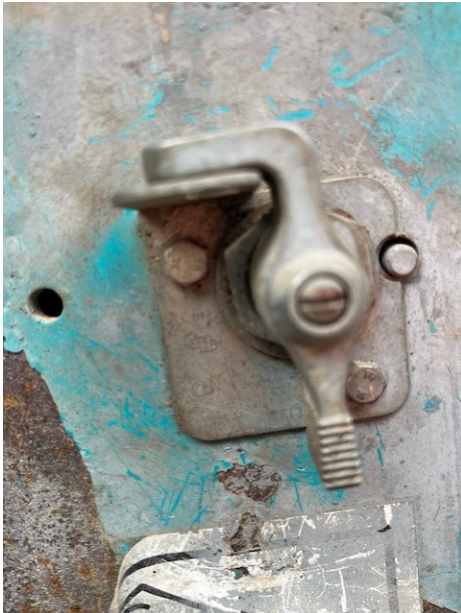
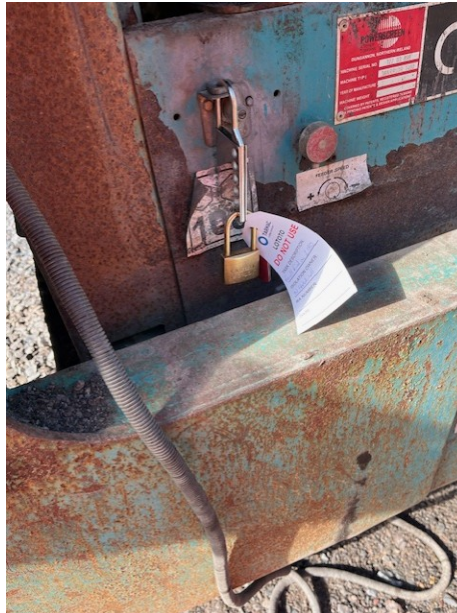
An isolation was required to allow a conveyor belt to be replaced on a Warrior 1400 Powerscreen. When following the LOTOTO process the isolation owner applied a hasp, padlock, and tag to the main isolator. However, during the try-out step it was discovered that turning the isolator only a few degrees allowed the engine to be started. The make of the isolator was Cole Hersee.

The images below show the isolator, the isolator with the hasp and padlock fitted, and operator demonstrating that the conveyor could be started when isolator turned a few degrees with hasp and padlock fitted.

On identifying the issue the work was stopped, the equipment made safe, and the isolator will be replaced.

- Following the **LOTOTO** process in full is **essential**.
- The Try-Out step in this case identified an issue with the isolator.
- Use this briefing note to reaffirm the importance of LOTOTO process and in particular, the Try-Out Step.
- Identify any Cole Hersee isolators on your site and test them to ensure they are in working order and that isolation can be carried out effectively. If not, replace them with one that meets our company's specification.
- Resources to support the sharing of key safety messages in relation to '**Fatal 1 - Contact with moving machinery and isolation**' can be reviewed and downloaded from the [Fatal 1 section of Safeguarry](#)
