# TRANSPORT - Rigid dump truck rollover

| INCIDENT No: | 04941 |

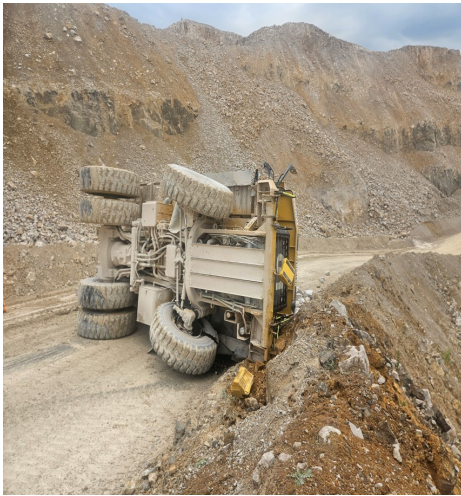
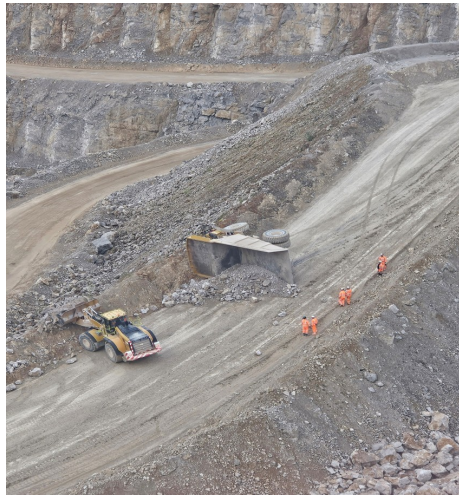
A quarry operator was travelling back to the crusher fully loaded in a CAT 775G. The haul route had become slippery shortly after a down pour of rain. As the dumper approached one of the main ramps from the top of the quarry The operator engaged the correct gear with auto retarder. As the dumper descended the ramp at a speed of approximately 9mph it began to lose traction. The operator had no control over the steering causing the dumper to hit the bund on the opposite side of the ramp. The sideways impact of the bund caused the dumper to roll over onto the cab side and prevented a more serious incident. Luckily, the operator was shaken but thankfully unharmed.

- The Operator was travelling at 9.3mph, below the sites speed limit.
- The operator was not using a mobile phone.
- The operator was wearing a harness belt.
- After a particularly long dry spell an unexpected heavy downpour of rain caused the ramp to become slippery.
- Certain parts of the ramp had become steeper in gradient due to years of scraping.
- A shovel was in the process of road maintenance on the ramp.
- Bund heights were maintained correctly which prevented the Dumper from rolling over the edge.

- Post incident alcohol test was completed & the test was negative.
- Ramp has now been built back up between 1 in 10 & 1 in 12.

- Correct ramp gradient maintained.
- Operators to pull over until roads/ramps are made safe.
- Risk assess driving conditions especially during significant weather changes & act accordingly. Stop & Think/Take 5
- Utilise Pix4D & Sodex technology to maintain gradients.
