Fatal 5 - Delivery driver killed in forklift truck incident. – MP Connect Alert

MPC SA04/2025 – 16.12.25

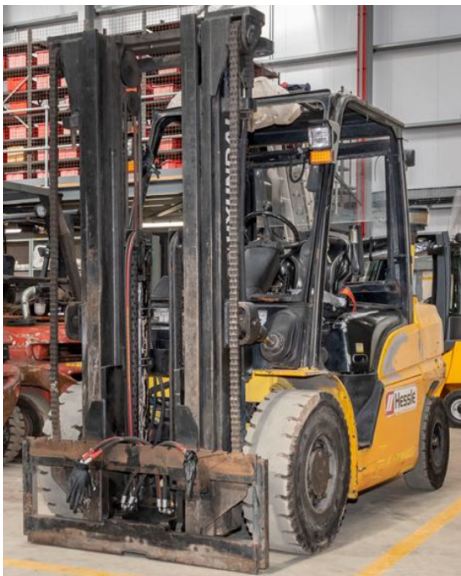
A delivery driver died when a forklift overturned as he reversed it onto a trailer; the forklift had undergone repairs to the transmission at the plant hire company.

As the driver reversed the forklift onto the trailer, it fell from the side of the trailer bed. Tragically, he was thrown from the seat and became trapped between the chassis of the forklift and a neighbouring trailer suffering fatal crush injuries. Failures in inspection, maintenance, and seatbelt compliance were contributory factors.

- The forklift had not undergone a full safety inspection after the repairs.
- Multiple defects were identified during HSE's post-incident examination.
- While pre-delivery inspections were performed for new hires, they were not consistently applied to machines returned to existing customers.
- Many operators rarely wore seatbelts and there was no system enforcing their use.

The image below shows the forklift truck involved in this incident.

- Implement robust inspection and maintenance regimes.
- Perform full safety inspections to identify and repair defects before returning equipment to service.
- Provide effective driver training focused on reversing protocols and load stability awareness.
- Ensure safe loading procedures with proper trailer support and qualified personnel during loading / unloading.
- Enforce consistent seatbelt use.

- Audit inspection and maintenance regimes, ensure after-repair safety checks are mandatory.
- Enforce seatbelt use through supervision, spot-checks, and disciplinary procedures.
- Review loading / unloading risk assessments to ensure safe trailer use and clear hazard controls.
- Train all forklift operators on proper use, load stability, and site-specific reversing risks.
- Introduce protocol for safe trailer positioning, lighting, and movement during early-morning operations.
- Support a safety culture with leadership oversight, behavioural safety monitoring, and incident follow-up.
