BEST PRACTICE

LOCATION:	Quarry	ARTICLE YEAR	2015
ACTIVITY:	Production and Processing	COMPANY:	Hanson UK
SUB ACTIVITY:	Aggregate processing	COMPANY LOCATION:	Cefn Mawr Quarry
BEST PRACTICE No:	BP1947	COMPANY TEL:	07966 499299
COUNTRY OF ORIGIN:	United Kingdom

Primary crusher wobbler improvement

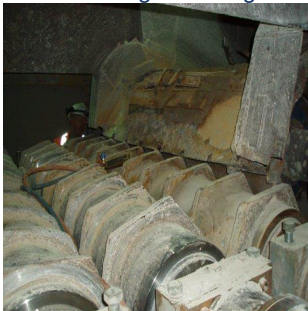
Before

In spite of previous improvements made to the wobbler system in the primary crusher at Hanson's Cefn Mawr Quarry, there were 16 wobbler stops during a six month period. These required employee intervention to clear blockages and reset the system. This was a hazardous task in a restricted workspace and resulted in more than 13 hours of lost production.

A root cause analysis, carried out by the quarry team, found that the one metre drop height from the laminator was causing large rocks to stun the wobblers dead. It was decided to remove the first wobbler from the system and replace it with a 30mm reinforced plate, set 500mm from the laminator, to reduce the impact and allow the stone to roll onto the next wobbler. This has been a very successful solution to the problem.
