BEST PRACTICE

Bespoke lifting device

During the shutdown in 2017, a £1 million project was undertaken on the raw mill at Ketton Cement Plant.

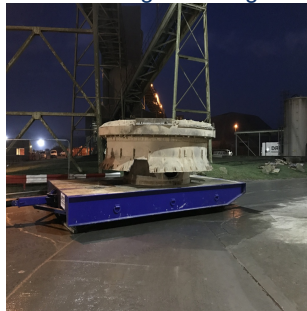
A bespoke platform was constructed in conjunction with a site contract company, Drury Engineering. This enabled the table and rolls to be lifted and lowered directly and safely onto the platform. The platform can be moved easily to the workshop area for repair. The trailer was designed to be towed by a front end loader. A new lifting beam has been installed in the workshop.
