BEST PRACTICE

LOCATION: Asphalt/Coating plant
ACTIVITY: Access & Egress & Working at Height
SUB ACTIVITY: N/A
BEST PRACTICE No: BP2044
COUNTRY OF ORIGIN:

ARTICLE YEAR: 2018
COMPANY: Tarmac Ltd
COMPANY LOCATION: Ipswich
COMPANY TEL: 0000

Fire protection project - baghouse fire

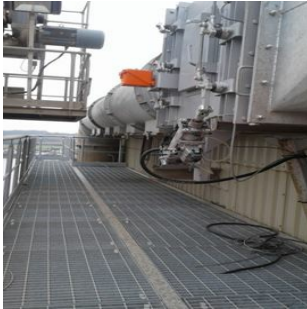
New walkways

To prevent any recurrence, remedial work included additional high-level walkways and extra pyrometer probes to alert the plant operator about the conditions in various parts of the plant.

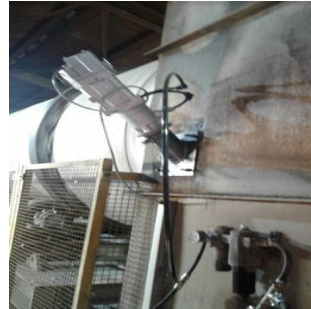
New probes
