INCIDENT ALERT

LOCATION:	ASPHALT/COATING PLANT	ALERT STATUS:	Normal
ACTIVITY:	TRANSPORT / DELIVERY	DATE ISSUED:	24/05/2022 20:29:38
SUB ACTIVITY:	LOADING	INCIDENT No:	03618

Driver severs finger on automatic tailgate

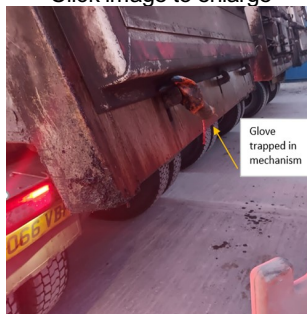
In the early hours of the morning, when it was dark, a contract tipper driver was carrying out his pre-start vehicle checks. These included opening the automatic tailgate to check for contaminants from the previous load. He then activated the switch in the cab to close the tailgate. Due to the engine only just being started, the lack of build-up of air in the tanks delayed the closure of the air activated tailgate and the clasps which secure it in place. The clasps closed as the driver was cleaning the tailgate, severing the middle finger on his left hand, which later had to be amputated in hospital.

- When the vehicle air tanks are fully charged, the operation of the tailgate clasps closing takes approximately 4 seconds. On this occasion it took 11 seconds.
- This is a task the driver carried out daily and had not recognised the risk previously.
- The swift actions of the site personnel helped getting the injured person the emergency assistance he required.

- A driver needs to be aware of the delay in the closing mechanism of an automatic tailgate when the vehicle's air tanks are not fully charged.
- Drivers should remain in the cab prior to undertaking the pre start check to ensure air in the vehicle is fully energised.

- Ensure drivers are reminded of the hazards associated with tipper tailgates through induction and ongoing training
