## BEST PRACTICE

| BEST PRACTICE No: | BP2065 | COMPANY TEL: | 0000 |

### POD truck cleaning project - WINNER

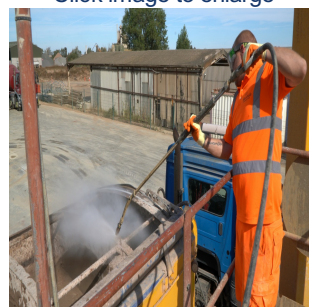
- A flexible scraper that contacted the walls was added to paddles; this significantly reduced the amount of mortar left sticking to the sides. All POD vehicles have had a standardised version of this modification installed.
- An adjustable pressure washer was fitted with turbo nozzles. The POD vehicle is moved alongside a gantry, an operator using the pressure washer is then able to clean the POD vehicles from above. The nozzle can be rotated to enable the operator to clean the nearside of the vehicle without it being re-positioned.
