## BEST PRACTICE

LOCATION: Quarry  
ACTIVITY: Access & Egress & Working at Height  
SUB ACTIVITY: N/A  
BEST PRACTICE No: BP2179  
COUNTRY OF ORIGIN:

TITLE
Enhanced access & egress safety system for emergencies.
ARTICLE

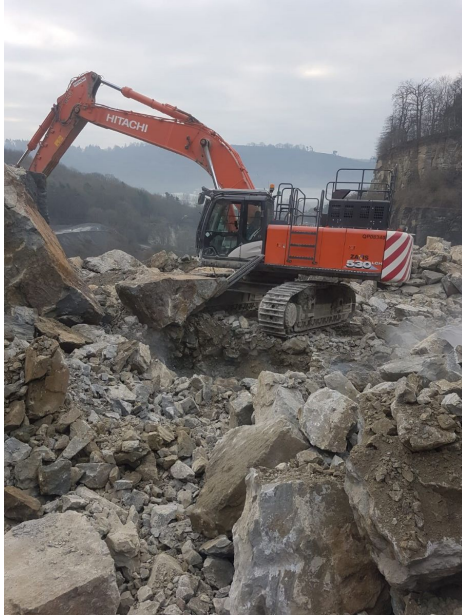
Excavator operative was working a blast pile, creating a bench and rock trap as required. Whilst carrying out this task, the operator decided to manoeuvre a large rock out of the way, which unfortunately naturally split. The top section of rock slid across the rock trap and hit the access platform of the Hitachi 530. The impact of this deformed the access system and the steps proximity switch had also been broken. This disabled the machine's ability to move from a potentially dangerous situation, e.g., further rock fall.

This occurrence has demonstrated the potential for an operator to not be able to track out of harm's way if such a system (access step proximity switch) is broken or breached. Currently they would rely solely on breaking cab glass and escaping, which could be deemed more hazardous outside of the machine's falling object protection (structure).

We wanted to identify a solution to the above, so that an operative can remove himself from a dangerous area without leaving the machine. Between ourselves and the excavator manufacturers, we have developed and installed an emergency bypass switch which enables us to do just this.
