## BEST PRACTICE

**Device designed to hold open the chutes on the rear door of asphalt tipper lorries. - Topic 6**

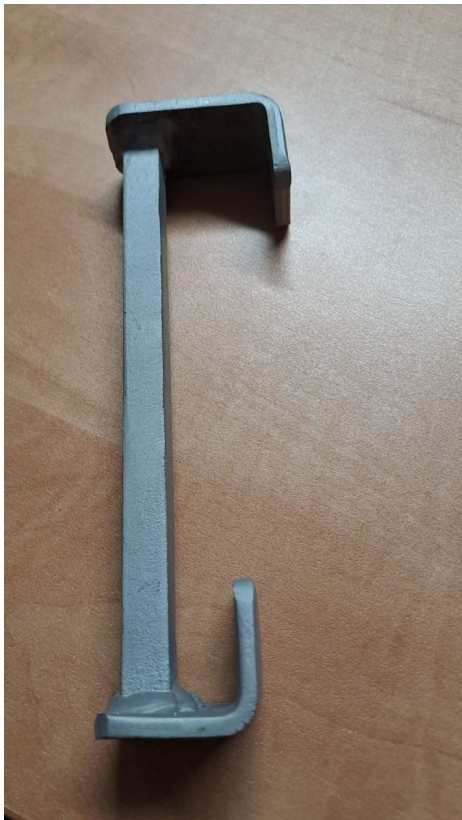
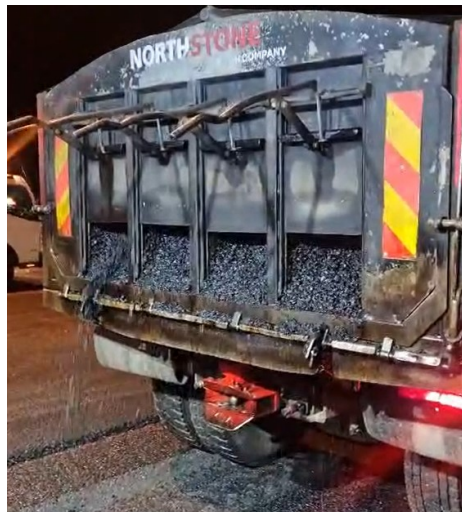
The images below show the device and the device being used.

The tail door on this style of tipper lorry is inset to the body rather than sitting external to it, so to close the tail door the contact surfaces need to be cleared. The driver has to either manually hold open or else insert a prop into the heavy tail door in order clear the door sill of hot material.

The issues associated with working around and clearing the tail door include - manual handling of the heavy tail door, contact with hot material (burns), nip/ trap injuries when removing props or closing the tail door and finally, additional time spent by the driver in a live site environment (close to road traffic, site traffic).

In 2023, a contract HGV driver received a hand injury which required stitches when the prop that he was using to hold the tail door open slipped and the tail door closed suddenly catching and injuring his hand.
