# SHE Alert

## Operative Struck by Crane Load

### Operative Was Struck by a Manifold During a Crane Lift

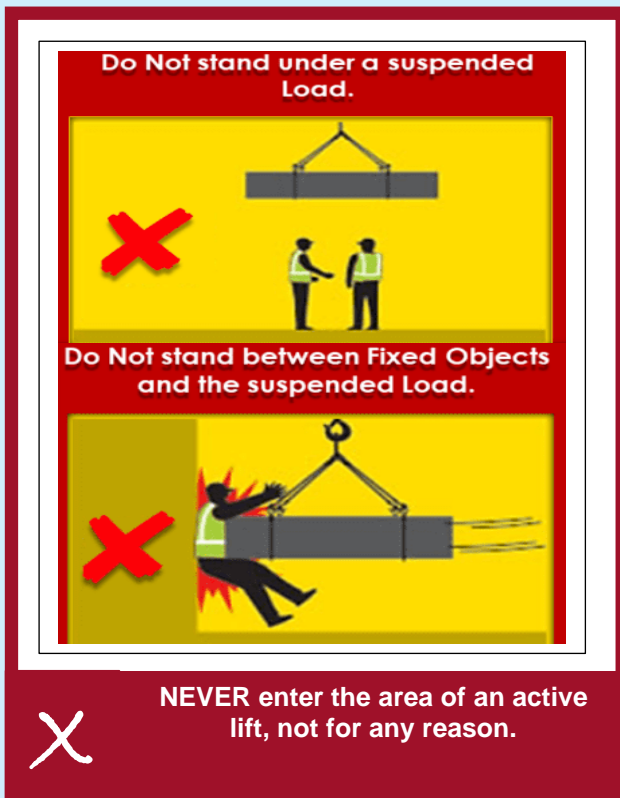
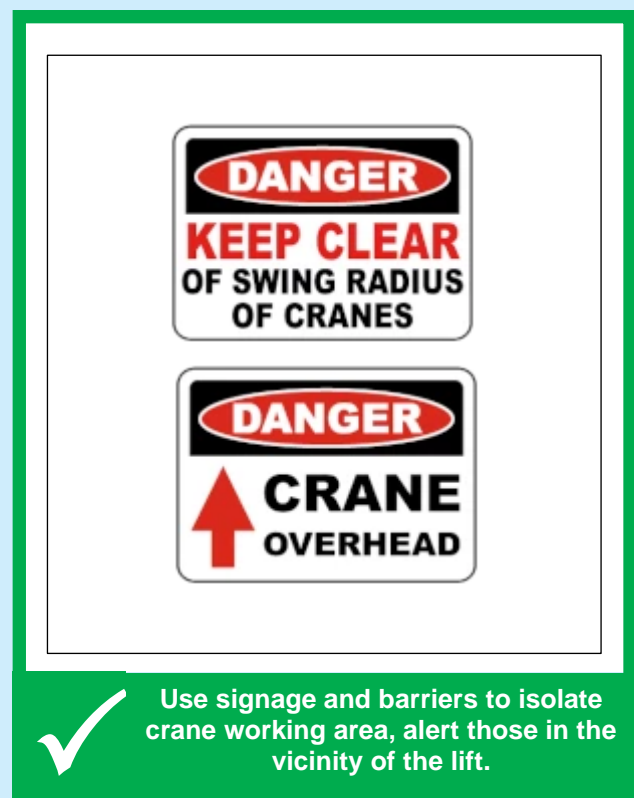
A maintenance operative was struck by a manifold whilst it was being lifted by a crane to allow access to the screen deck. A permit and lift plan had been written.

During the lift the manifold became caught on a protruding bolt, the maintenance operative approached and levered the manifold off whilst the load was still in tensions in 'lift'.

When the load was freed, it swung back and struck the IP who suffered bruising to their ribs.

1. Clear assessment of the hazards must be completed prior to any job, all parties involved must discuss and agree, then sign the risk assessment and method statement.
2. Exclusion zones to be maintained to only allow designated crane team into the lifting area.
3. <https://www.hse.gov.uk/construction/safetytopics/lifting-operations.htm>
