Sharing good practice 2006/07

ENTRIES FROM THE HEALTH AND SAFETY BEST PRACTICE AWARDS

This guide summarises the ideas and innovations to come from the Quarry Products Association's *Health & Safety Best Practice Awards 2006*.

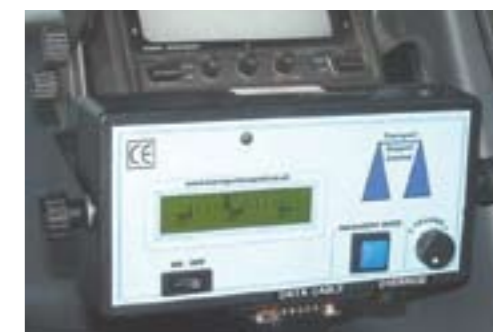
> Inclinometer to prevent tipper overturns

After several incidents of articulated lorries tipping over when unloading bulk materials at Hanson's UK sites, measures were introduced to address the problem. An inclinometer was fitted to a Hanson articulated tipper. The electronic sensor is attached to the trailer and detects lean, preventing the driver tipping if an unsafe angle is reached.

This original device was not sufficiently sophisticated, however, and was redeveloped to improve reliability and accuracy. Since the modification, drivers have expressed their views that the inclinometer has reduced the risk of overturning and has led to tipping areas which were previously regarded as 'border-line' being re-categorised as unsafe.

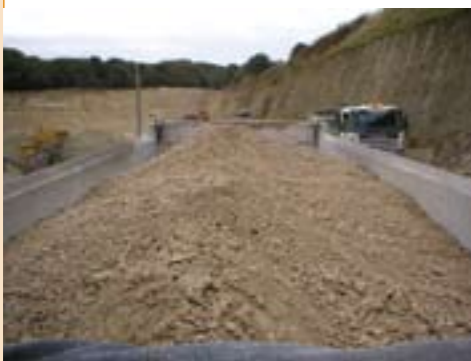
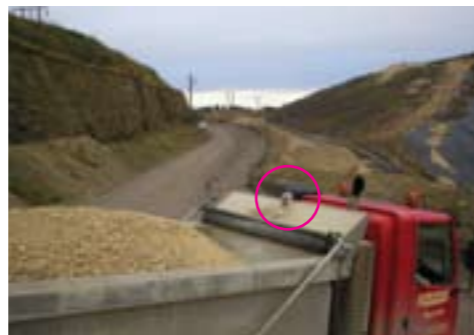
CCTV cameras in the front-inside of the vehicle body. The image is then relayed to a monitor in the cab. The driver can now observe, visually, the loading and discharging operations from the safety of the vehicle cab, assessing if there is likely to be any danger of the lorry tipping.

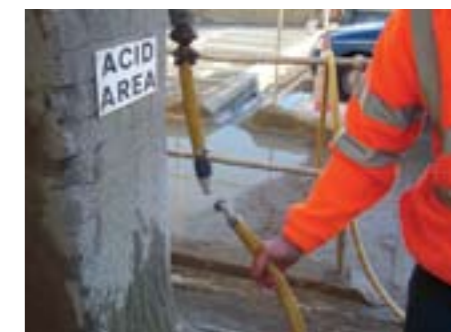
> Preventing hose 'whiplash'

During 2005, there were several 'near hits' involving truck-mixer drivers forgetting to remove the water hose attached to the vehicle's water tank during loading. This resulted in hose couplings being stretched and flying off in a "whiplash" action. The solution was simple and cheap, but effective. A quick release "in line" connection was placed between the hose bayonet connections, so that when the hose reaches maximum tension it merely detaches, rather than whips violently.

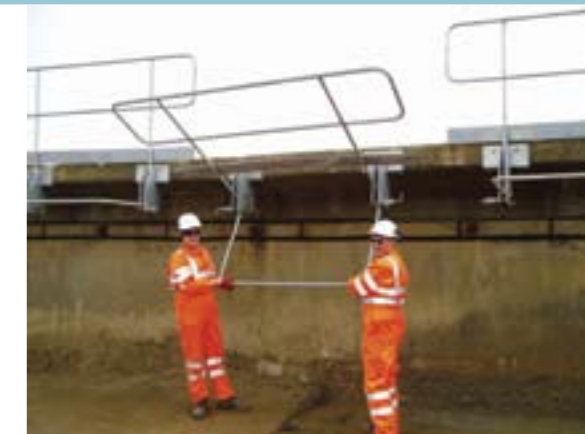
The quayside walkway is 2.6 metres higher than the stockyard, requiring handrails to be removed to allow ships' discharge conveyors access to the shore-side receiving hopper. Previous designs had progressed from posts and chains to slot-in barriers and most recently sliding panels, each presenting its own limitations and hazards.

In response to near hits and a revision of risk assessment, a working party was formed involving wharf staff of all levels to evaluate the hazards involved.

The group identified a specification and led the development of retractable handrails which revolve downwards around a pivot point that is easily operated from ground level.

Before retracting the handrails, pedestrian access to the quayside is restricted by means of barriers and warning signs. The operation can easily be carried out by two people, controlling the movement with a lever section protruding at 90° to the main handrail section. After discharge, the procedure is reversed with the handrail sections secured by means of spring-loaded bolts and pedestrian barriers removed.

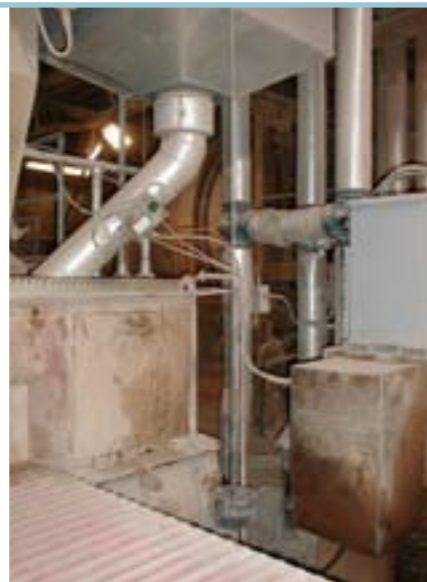
The binder weigh kettles at this site are located above the mixer boxes, almost 4 metres above floor level with no dedicated access platform. When routine calibration was required, 300kg weights had to be carried upstairs to the walkway next to the weigh kettles. The bitumen pumps and trace heating were then isolated to remove any risk of burns and the area beneath cordoned off in case a weight was dropped.

Instead of placing the weights on top of the kettle, they are now suspended beneath. Beams were fitted across the tops of the weigh kettles, with wire ropes hanging down either side to floor level. Each wire rope was then passed through lengths of metal tube to keep it ridged and a small base plate fitted for the first weight to rest on. Round interlocking slotted weights are then placed on top of the base plate with the metal tube passing up through the slot. As weights are added to the stack, they are turned to lock them together on the metal tube.

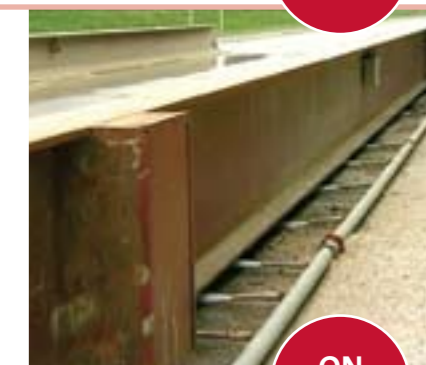
The quarry manager has now found a more effective method. A two inch galvanised steel pipe has been attached alongside the weighbridge complete with several taps which release a fine spray underneath the bridge.

For just £500, the new system has reduced manual handling and the risk of slips, trips and falls. The manufacturers of the weighbridge consider it to be good practice, as it maintains accuracy of the bridge for longer and makes it easier to maintain.

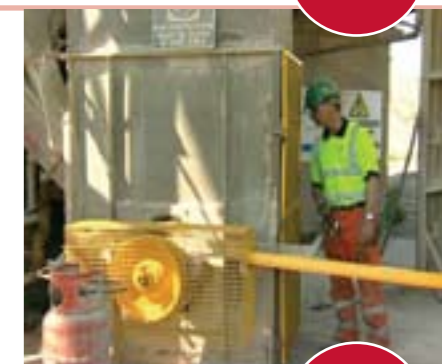
Engineered on site, a small extension was welded to the bottom elevator shaft. The simple task is to slide a hub wheel onto the bottom shaft, then attach the winch cable to the hub. The cable is wound onto the hub before being secured to the shaft using a locating pin. The easy fit guard to protect the operator from any moving parts can then be fitted into place. The winch is activated with a remote switch held by the fitter. The elevator now moves in a slow, smooth and controlled manner. If work is needed on the elevator, a lock off/isolation is fitted to the 12 volt battery supply.

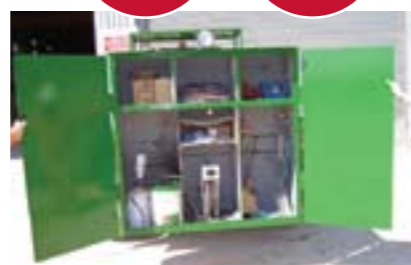
Greasing the machinery and equipment was a manual task that required the operative to continually climb up and down a ladder. Using the greasing gun also brought risks of repetitive strain injuries. The problem has been addressed by installing a small compressor onto the back of a wagon, along with pneumatic greasing equipment and an inertia hose reel. Once the lightweight reel has been pulled out and attached to the grease nipple, the compressor will do the rest.

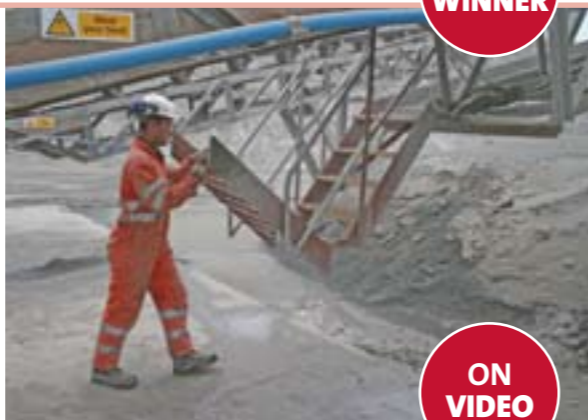
Spillages are mechanically removed from this site using a JCB, but some manual cleaning was still necessary around steps and access ladders. CEMEX's solution eliminated manual handling and prevented damage to the steps and ladders from accidental collision with the JCB bucket. The ladders and steps were hinged and can now easily be lifted during cleaning.

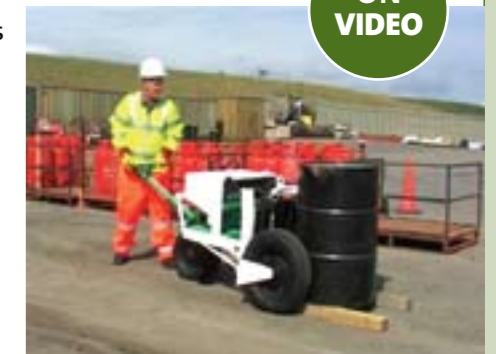
An easily transportable unit with a hydraulic lifting attachment has been designed. When 200 litre drums are offloaded by the delivery vehicle, they are placed on level ground with wooden straps below them to leave a minimum of 50mm clearance. This means that the forks from the device fit under the barrel and allow it to be lifted hydraulically. The unit is fitted with pneumatic tyres to facilitate easy movement.

In addition, a pallet cart was purchased and the site fitters were tasked with designing and building a portable sprayer. This can be connected to the 200 litre drums without the need for any manual handling of barrels. An easily operated hand jack operates the forks for raising and transporting the barrel, which is chained to the portable sprayer prior to it being moved.

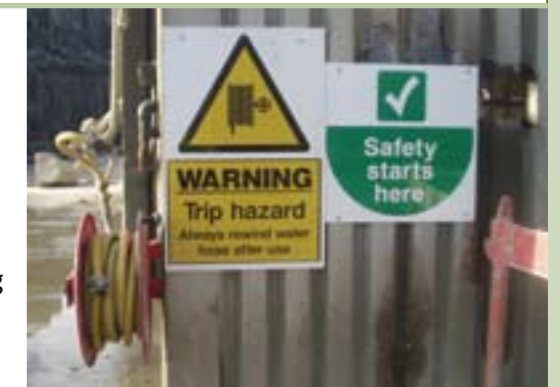
One of the main causes of health and safety incidents at Duntilland is from slips, trips and falls caused by objects left on the ground. The long water hose, which is used to fill the water tanks on trucks, is the main problem. In order to avoid the possibility of the hose lying around, a fire reel has been installed, which can be swivelled around a vertical pivot and has been placed at a suitable height to prevent the need to bend over, thus reducing the risk of back problems. A warning sign has also been installed as a reminder that the hose should be wound back onto the reel after use.

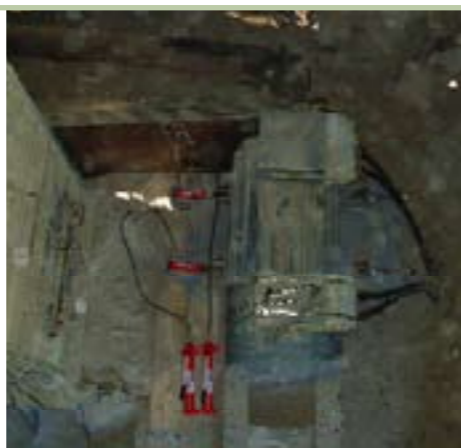
A build-up of compacted fines made it difficult to loosen and change the primary crusher blow bars. In the past, a 14lb copper sledge hammer was used to dislodge the bars. However, this brought a risk of repetitive strain injuries and being hit by flying shrapnel.

The solution was to install an Invicta vibrator to shake the bars free of the compacted fines. The vibrator was attached to a purpose-made frame from which it could perform its task.

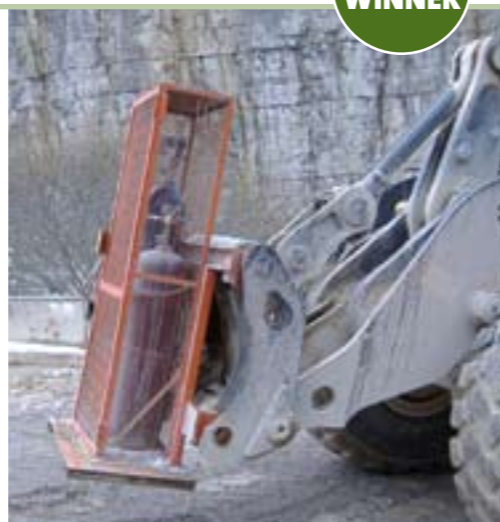
A simple tool for transporting gas bottles has greatly improved safety standards at this Derbyshire quarry, but could also be of benefit to many other sites. Instead of manually transporting the bottles, a lifting attachment has been created, which connects to a Volvo L-150 loading shovel. The shovel comes with a "quick hitch" facility for a lifting beam and a fork attachment. The quarry fitters fabricated a secure cage to hold the gas bottles, attached to a replica of the "quick hitch" part of the lifting attachments.

The bottles can be placed anywhere effortlessly, and replacement bottles are easily exchanged. The concept could be used for other purposes, such as moving a bunded gas oil tank.

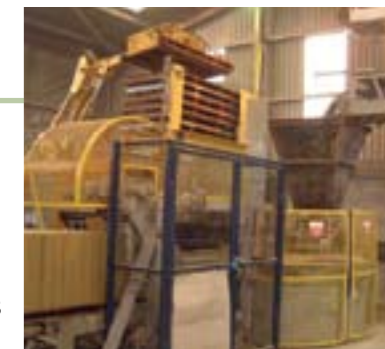
A build-up of material was occurring in the transfer hopper because of the feeding of semi-dry concrete into the slab press. The way that this had been dealt with in the past was by installing vibrators to the sides of the hopper and for someone to clean the insides manually. This was undesirable because the hopper was accessed from a ladder into an awkward and confined space. In addition to this, the cleaning process was only a temporary expedient.

The machine operator led the development of a hopper lined with thick conveyor rubber. This has produced a hopper that rarely suffers from build-up of semi-dry concrete. This solution has also removed the need for heavy manual intervention as, on the infrequent occasions that the material does build up, it is released via a simple tap on the side.

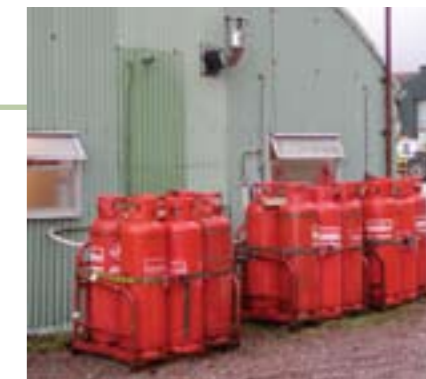
BEFORE

There are devices to measure the flow of gas, with a safety cut-off valve that can work if the flow of gas is too low, indicating a leak. The tanks are scheduled to be refilled when they drop to 25 per cent capacity, to ensure an uninterrupted supply.

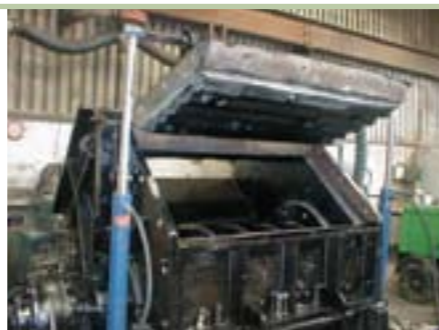
It was decided to create a hydraulically operated door and hinged front panel to remedy these health and safety issues. This also included a mechanism for retaining the top hinged door whilst open. This system was then applied to the remaining crushers.

Manual prop should also be used in case of hydraulic lift-ram failure

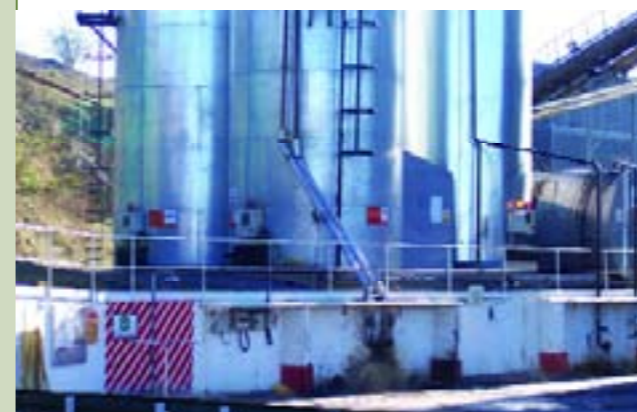
Each connection flange is labelled with the tank number and the grade of bitumen contained within the tank to which it is connected. Close to the connection flanges, gauges display the tonnage of bitumen contained within each tank along with the safe working capacity of each tank. Each tank is also fitted with an ultimate high level probe with a warning light and siren above the connection flange. Any drips from the flanges are contained within a tray incorporated into the discharge point, which is filled with water for cooling and solidifying the bitumen.

Finally, an emergency shower is available at the discharge point which has been protected against frost by insulating all pipe work above ground.

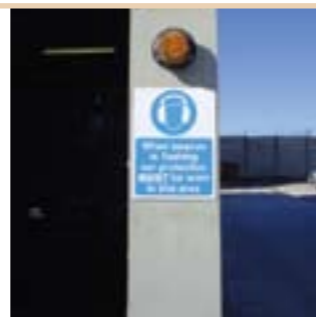
A device has been created which monitors the noise levels in the loading bay area and, at a pre-set decibel level, will activate a series of flashing beacons indicating that the area is now a designated hearing protection zone. This innovation offers a highly visual and instant alert to all staff and visitors that noise levels are approaching mandatory protection level. It also means that ear protection does not need to be worn all of the time.

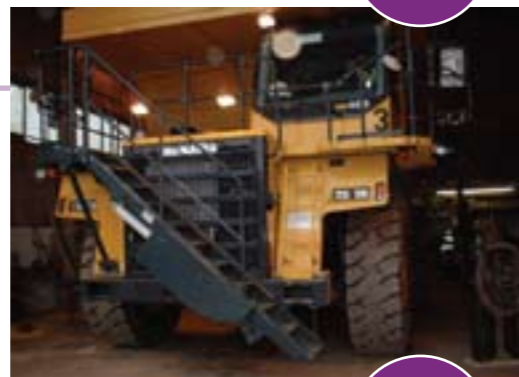
Instead, inclined steps have been designed and manufactured, which can be lowered to within 350mm of the ground. They are fixed across the front of the radiator with the last three rungs retractable by twin air rams. Handrails are provided along the length of the stairway and across the front of the dumper to reach the driver's cab door.

The steps are controlled by the use of a switch at ground level and a duplicate switch in the driver's cab. Indication lights show whether the steps are in the lowered "park" position, or the raised "travel" position. An audible warning in the cab sounds if any drive gear is selected whilst the steps are not fully in the travel position. An additional feature is extra lighting of the whole access step area.

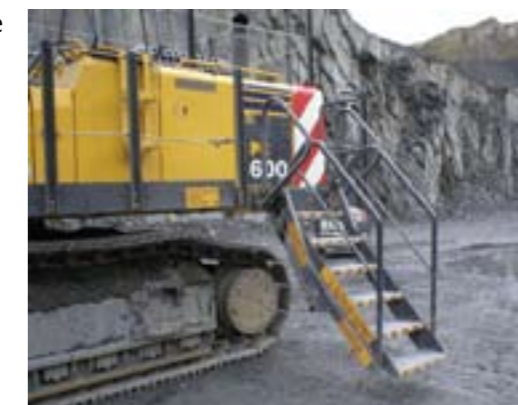
- lighting for the stairway system
- external ground-operated light switch fitted, which can be switched on before accessing the machine
- extension of walkway length around front of cab and, but reduction in width. An operator noticed that the width of the walkway had been dictated by the need to fully open the cab door. He felt that this made the walkway too wide, causing potential structural failure or impact risk. He requested a reduced width walkway but with an extension in length beyond the cab to allow easier access to the cab without any need to fully open the door

- installation of plastic-coated wire handrails on walkway and engine area as the tubular steel handrails had been replaced several times owing to vibration of the rigid structure. The new handrails provide protection from falling, but are flexible during motion of the machine

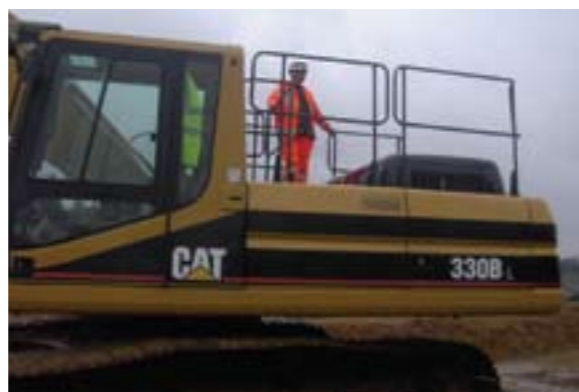
> Caterpillar 330BL handrails

The solution was to install handrails. The handrails were constructed using 30mm tubular steel as smaller separate units to decrease vibration and reduce stress on the joints. Handrails were not placed at the very rear of the excavator to allow the engine canopy to open fully and maintain visibility. The operator found the addition of handrails made the area safer to work in when carrying out his machine checks. There was also no impact on all round machine visibility.

Note: Sites wishing to emulate this practice should consider the addition of 'kicker boards' to constrain slips, also the application of non-slip overlays to horizontal walkway areas, where necessary.

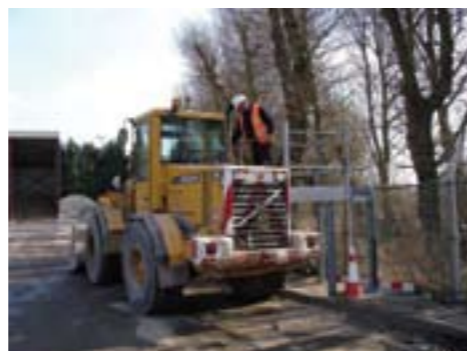
It was felt that a safer method needed to be introduced. Their solution was to erect a purpose-built working platform that the loading shovel could park alongside and allow an operator/engineer to safely top up oil and water levels. The platform has handrails and kickboards to prevent falls. The total cost was under £400 and it took some 24 hours to build.

Note: Access platform would be even more user-friendly if a set of inclined stairs were to replace the vertical rung access.

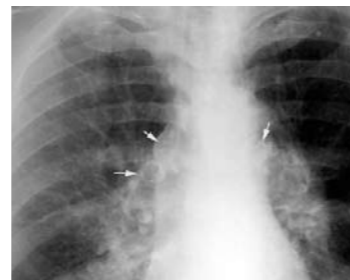
Alveoli
'Respirable' means fine enough to reach the alveoli
