# Sharing good practice 2007/08

ENTRIES FROM THE HEALTH AND SAFETY BEST PRACTICE AWARDS

This guide summarises the ideas and innovations to come from the Quarry Products Association's *Health & Safety Best Practice Awards 2007*.

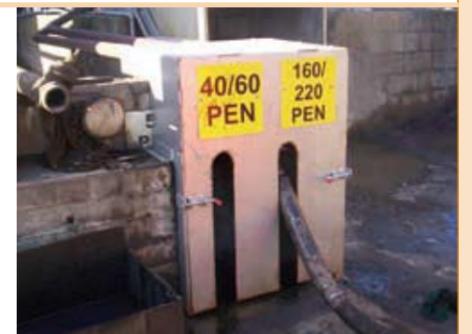
A unit has been designed for the safe unloading of bitumen at this site. It has a front panel which is hinged and has spring loaded locking pins. When the tanker is not unloading, the door can rest upon the top of the unit and is locked in place by secure spring loaded pins. When the driver hooks up to the loading point, the pins are released and the door is closed. Once again the pins lock in place making the door secure.

If for any reason the filling pipe becomes loose or a seal fails, the bitumen would not spray dangerously but instead be contained in the unit and drop to the floor. This unit helps protect the driver and other members of staff.

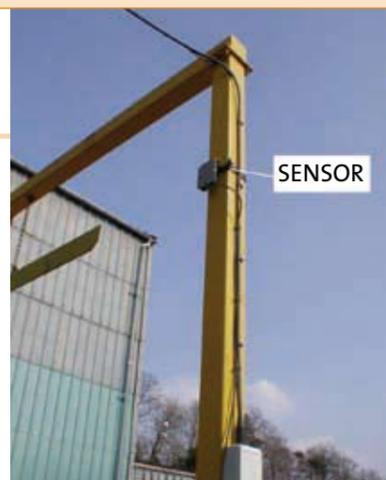
Initially the problem was addressed by erecting a goal post on the approach to the plant with a swinging plate suspended at the correct height. This alerted the drivers to the height restriction. However, this did not eliminate the problem as some drivers were unaware that they had struck the hanging plate. Another solution had to be found.

The solution was to adapt the detector beam sensor used on the sites' roller shutter doors. The sensor was developed to include an audiovisual alarm, that alerts drivers if their vehicle is beyond the size limit.

The alarm sound ceases after a short while to avoid prolonged disturbances to members of the public. This new alarm system has already averted potential problems and has allowed site personnel to talk with drivers that have activated the alarm to provide instructions on how to avoid a collision.

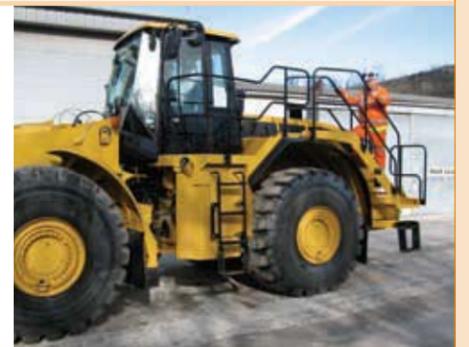
By designing and installing a purpose built access platform to the machine, safe access and egress is now possible and no similar incidents have been reported.

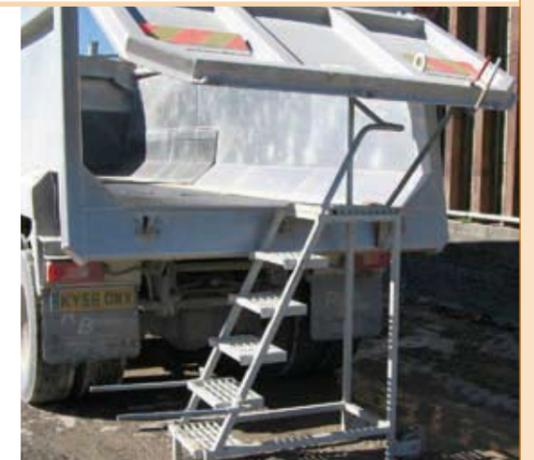
- A set of steps fitted with a handrail, wheels and extending handles (to enable easy manoeuvring); and
- a device to hold the tailgate open.

Drivers are now able to access the back of the lorries safely, enabling them to clean out the bodies. The successful measures have been introduced to other sites.

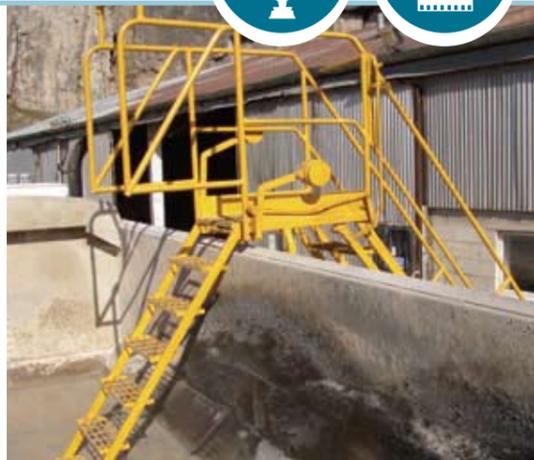
The steps also lower towards the body of the vehicle, improving the safety of the descent.

Overall, the risk to drivers when accessing the body is substantially reduced.

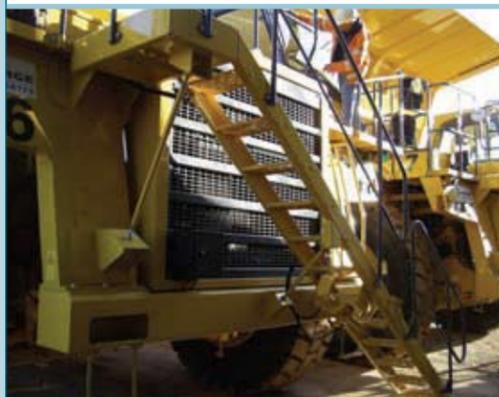
The team at Mountsorrel Quarry introduced three changes to reduce the risk of falls from their fleet of vehicles.

Each operator was provided with a back pack designed to accommodate a flask, lunch box, newspaper and mobile phone, so that drivers could maintain three points of contact when entering and exiting vehicles.

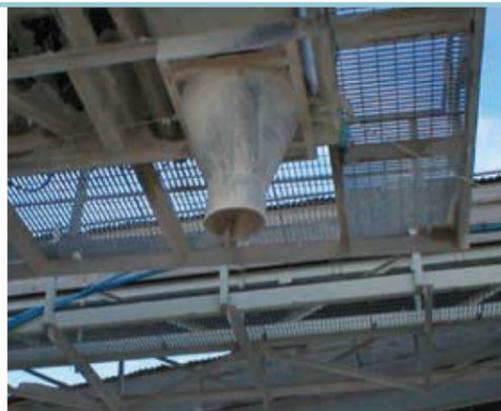
To avoid these issues a fitter has devised a chute, suspended on wheels, that can be moved in and out of position from ground level, removing the need for manual handling and working at height.

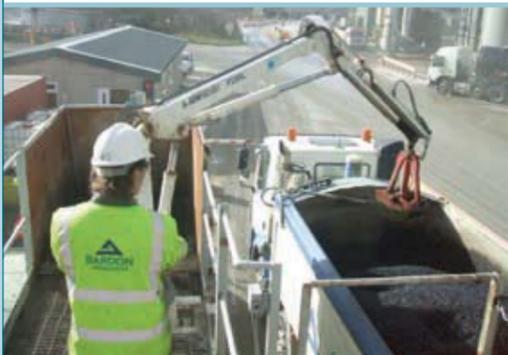
## Safe sampling system

A number of measures have been introduced at this quarry to improve the sampling process.

Drivers enter an area segregated from site traffic to avoid congestion. They then exit the vehicle to meet the technician, who closes traffic barriers.

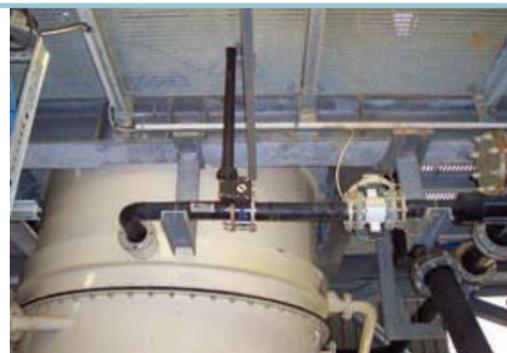
To eliminate the working at height hazard, a geared valve system was installed. As a result operators now control the teeter water valve from the same floor level as the Hydrosizer's sand density monitors.

This solution has eliminated the Work at Height hazard and stopped the repetitive actions required to control the processing equipment.

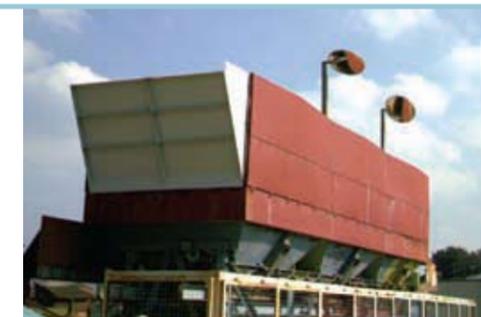
Concerns were raised that a ladder needed to be used to check that the bins were empty as there was no other means of access or Egress. It was felt that this was not an acceptable means of access.

To rectify this, convex mirrors were fitted on a scaffold pole above the bins. Now the plant supervisor can check the bins from his Batch cabin, without needing to go into the operational area.

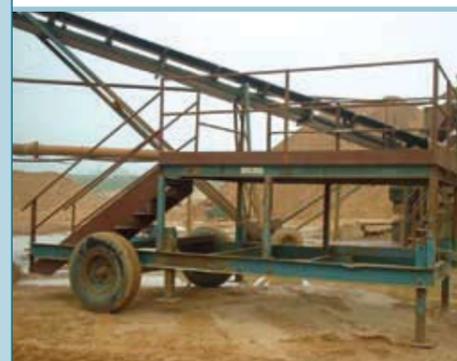
## Mobile access platform

Easton Quarry operates a mobile Powerscreen washing plant with an in-line Hazemag impact crusher. As is typical with such older manufactured equipment, access for maintenance was restricted.

Lafarge operatives looked to resolve access issues around the plant and decided that rather than attempting to install walkways and working platforms at each point on the plant a mobile working platform would be a better solution.

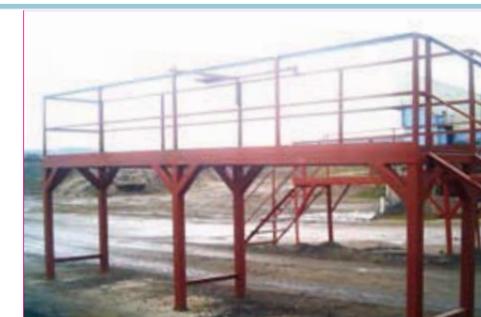
Sampling from asphalt lorries was highlighted as a safety concern within the business. A new employee felt that the existing platforms were not suited to the vehicles being used.

As a result a new platform was designed with improved access for sampling and reduced manual handling.

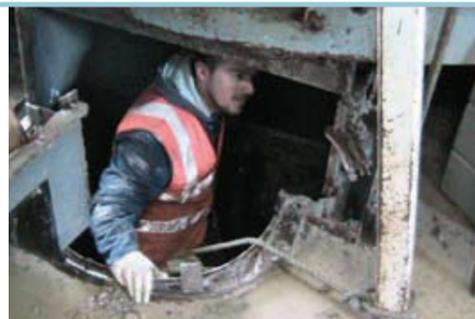
A lack of access into this chute prevented staff from easily cleaning out the hardened concrete. Using an air chisel meant great discomfort, caused manual handling issues and carried a potential fall risk.

To counter this, a working platform was fitted inside the chute to allow access for an employee to stand and work.

A task that was uncomfortable, claustrophobic and potentially dangerous, can now be undertaken with relative ease.

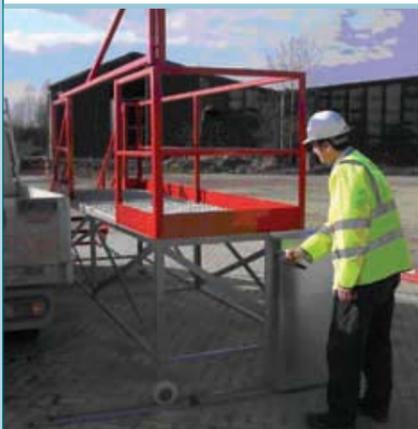
## > Mobile asphalt sheeting bay

Following a review of working at height activities at Baston, it was noted that several customers were standing on the back of their pickup trucks to sheet their asphalt loads.

When questioned, they stated that the lorry sheeting bays were not adequate and posed a risk to their safety.

The result is a simple and safe solution to a potentially hazardous situation.

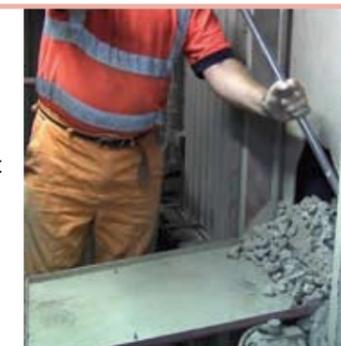
Poor design of the asphalt plant at this South Wales quarry had caused avoidable risks for site personnel. On occasions when the over-size stone chute blocked, the only way to unblock it was to lower a harnessed worker into the bin and tackle the blockage from below – clearly a highly hazardous task. To resolve this, an external lockable access hatch was built which has enabled workers to access blockages from above, in complete safety, from outside the chute.

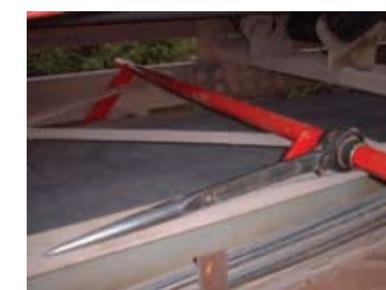
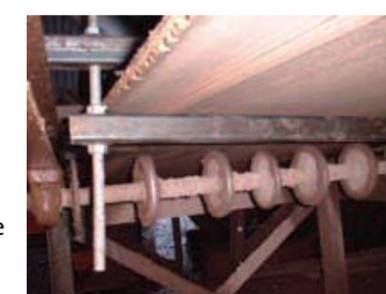
The fitting of the lift devil is completed quickly and safely by just one person. The uppermost longest bar is placed across the top side on the conveyor chassis with the locator legs either side of the belt. The small short bar is then placed into the locator legs and the 6mm retainer bolt fitted. This bolt is fitted so the small bar cannot be dislodged from their locator legs. With the ratchet podger fitted to the hexagon bar on the end of the top bar, the adjustable spanner is used to turn the top bar. The ratchet podger stops the small bar from going back on its self and so holds the belt clear of the roller, which means it can then be replaced in a safe and controlled manner.

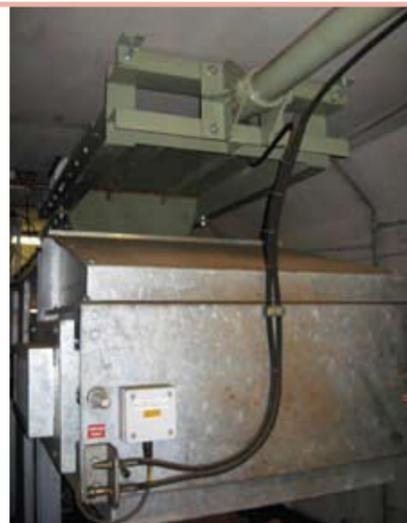
A safety plate was put in place to slide across and cover the gap which existed above the belt feeders. A hydraulic system was used which enabled the plate to move without workers having to place and remove it, which took away a potential manual handling issue too.

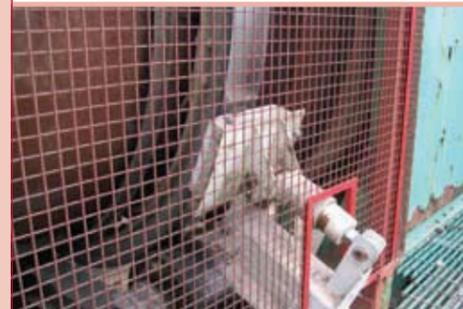
A device was developed that would grind the rings without an operative having to come into contact with any moving machinery. The device involves putting a fixed block onto the chassis of the dryer that has a spring loaded grind stone that

can be wound into position from outside the guarding. Over a period of time the grind stone wears the high spots from the ring of the dryer thus truing the circumference enabling the accurate tracking of the barrel.

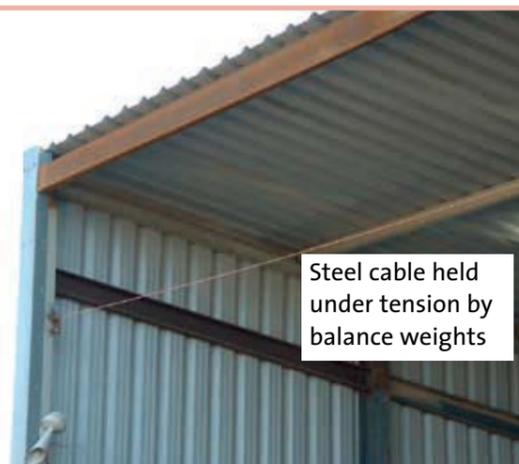
The final version uses a steel cable that is tensioned by balance weights that are connected to a limit switch. The system is powered by either mains or battery and creates an audible warning for drivers. This measure has greatly reduced the risk of collision between the vehicle and the bay roofing.

Steel cable held under tension by balance weights

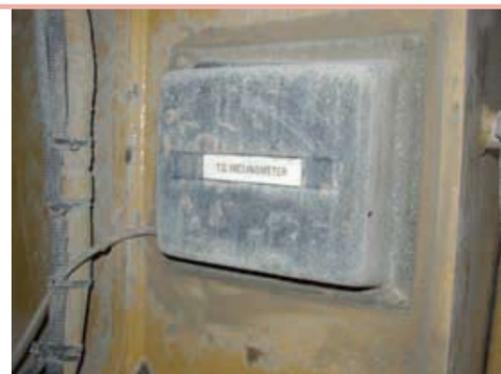
An inclinometer was fitted to the asphalt plant stock loading shovel following an incident where an arctic overturned at Dene Quarry. The arctic trucks discharge their loads adjacent to the shovel, and when doing so need to drive slowly forward with the body fully raised to completely empty the load. It is vital that the ground is even as if it is not the arctic trailer can become unstable and cause the vehicle to overturn.

Small inclines can lead to an overturn – especially when combined with windy weather and damp material sticking inside the lorry body. The display on the device indicates the extent (in degrees) and direction of any crossfall measured by a sensor. If required the driver can level the surface until there is no cross gradient in the tipping area.

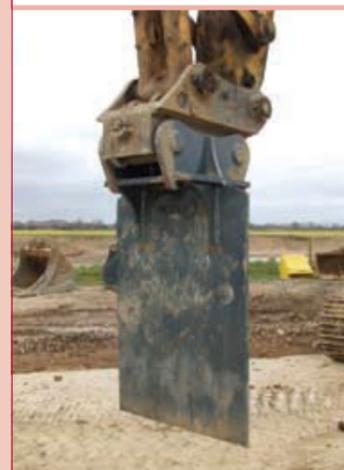
It was decided to manufacture a steel plate which would fit onto the reciprocating tray with a quick hitch attachment which could then be fitted to the site excavator. The excavator would then lower the plate into the hopper at the rear of the feeder plate and gradually push the material forward.

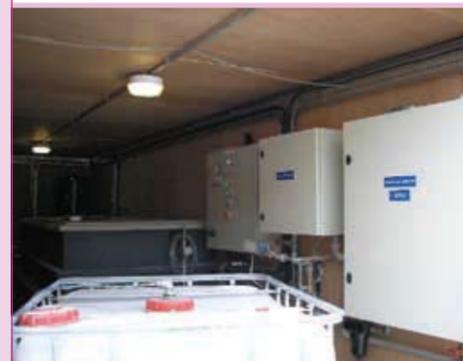
A dust suppression system has been incorporated into the new crushing and screening plant at Halkyn Quarry. This is a foam system which helps control the airborne dust created by impact crushers and the associated conveyer points found in the plant.

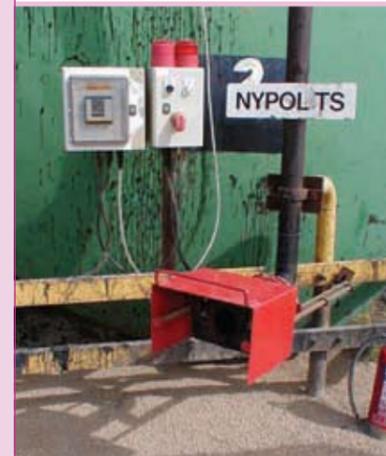
Following trials, the team devised a pull over cover that could easily be fitted to all bitumen delivery flanges. If there is a disconnection during the discharge the cover will act as a safety enclosure to protect the tanker driver from bitumen sprays.

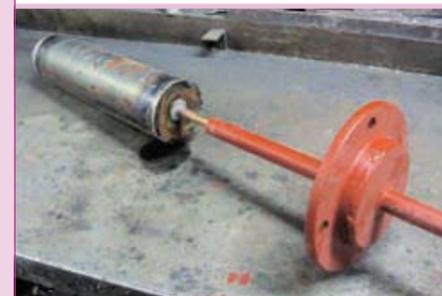
The system is a simple copper tube attached to a copper float that moves up and down a visible calibrated gauge as the storage tank fills and empties. This is marked with the tank readings, and corresponds with the electronic readings. It is also colour coded to match the electronic monitoring system:

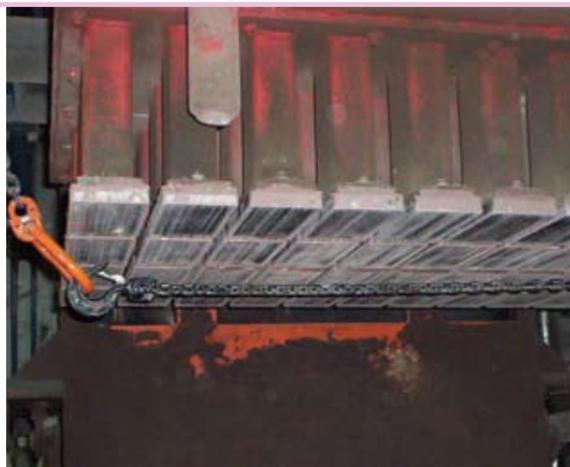
To provide a safer environment, a safety chain has been designed which is placed around the tamper head and the mould tooling to prevent any movement at all in the tamper head, should the hydraulics fail.

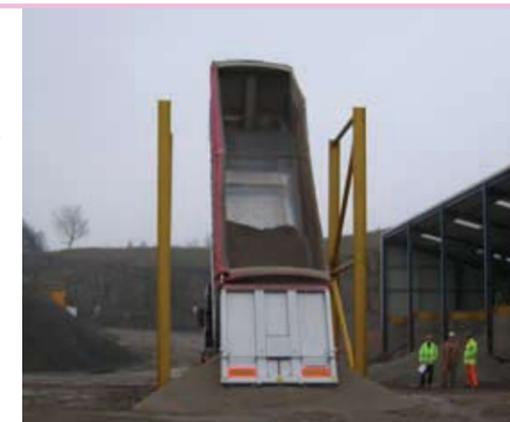
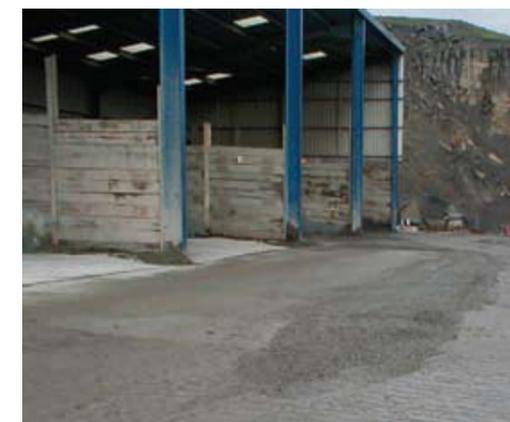
- A level concrete pad was laid in front of two aggregate sheds to allow articulated vehicles to tip parallel to the bays. The loading shovel then pushes up the load into the bay. Previously, restricted space meant vehicles could not align the cab and body when tipping.

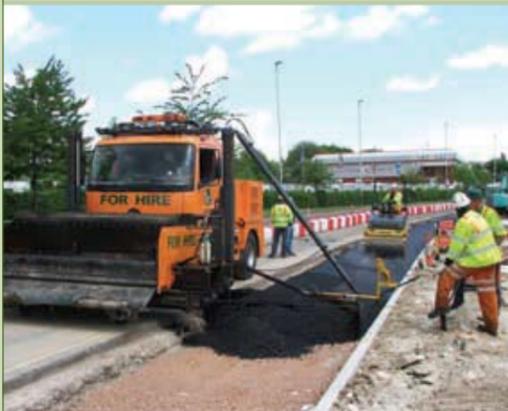
There was a problem when it came to effectively placing material in areas too small for pavers or other traditional forms of machinery to work. In this circumstance, it was normal for the work to be carried out manually which was an arduous practice and could lead to inconsistencies in the quality of the work.

The Sidewinder has been created to overcome this issue. It can place up to 1000 tons of material per day which is considerably more than can be achieved through the use of manual labour. During the process, the material goes to the front of the hopper and can then be transferred to whichever side is appropriate.

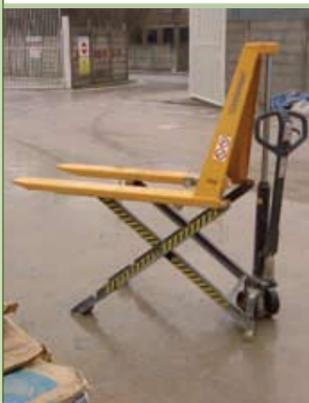
Concerns were raised by operatives regarding the lifting and bending involved when batching. The operation involved adding steel wire which came in 25kg boxes. The wire had to be introduced slowly on to the material batch belt as the weight being lifted caused problems to the operators..

To overcome this issue, a pallet lifting device has been introduced. This has reduced the number of bending and lifting movements by plant operatives.

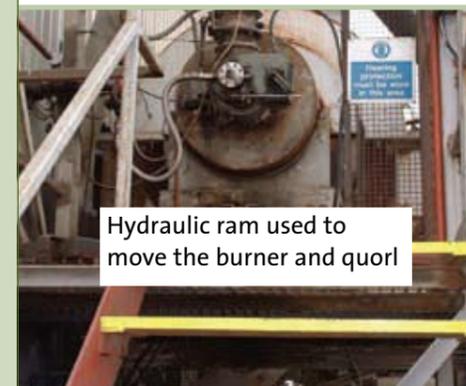
Hydraulic ram used to move the burner and quorl

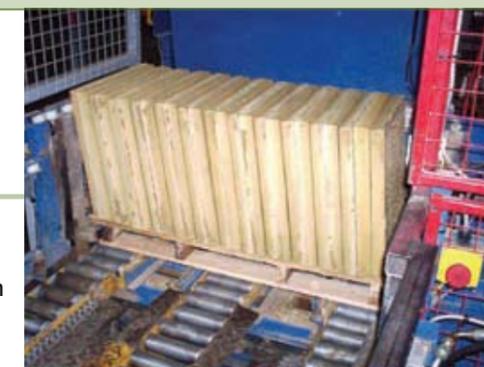
Slabs collated onto a pallet leaning against a support rail

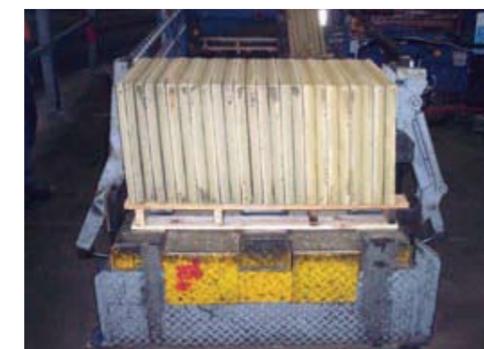
Slabs at the end of the conveyor. Eliminating need to climb onto conveyor and hydraulic arms to straighten slabs.

To overcome the first issue, the banding station was moved to the end of the conveyor where operators could remain at floor level. This allowed operators to work at a more convenient height whilst lifting seconds and rejects from the pallet and eliminated the need to climb onto the conveyor. The second issue was addressed by the installation of two hydraulic arms that replaced the manual arm, eliminating the need to manually pull the slabs vertical.

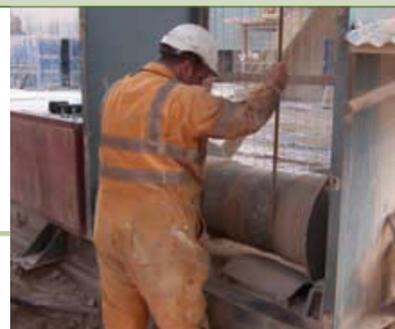
For safety reasons, these ropes are changed every six months. Removing the ropes was a straightforward process but reattaching new ones carried with it safety issues. Reattaching the new ropes to the winch and re-tensioning them required an operative to hold the ropes on the winch, while another operative electrically wound the drum. This procedure carried manual handling and entrapment dangers.

Before

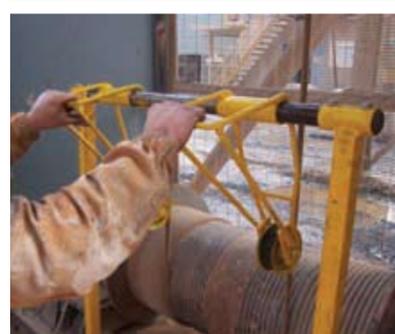
New equipment has been put in place which protects the operative from the dangers of the winch and rope.

After

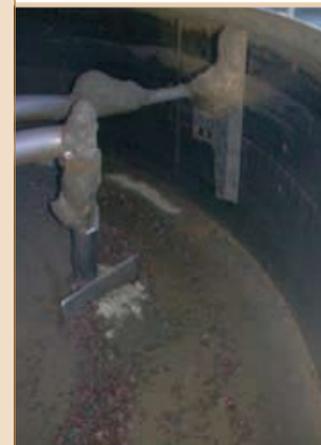
The Readymix sector has always been aware of the dangers that are presented from panmixer cleaning. This is because it can involve operatives climbing inside the unit which has caused a number of injuries such as slips, trips and falls, contact with fresh concrete, manual handling injuries and being struck by the objects contained in the unit.

Automatic washout system have helped improve the situation but there is still a need for an operative to manually clean them.

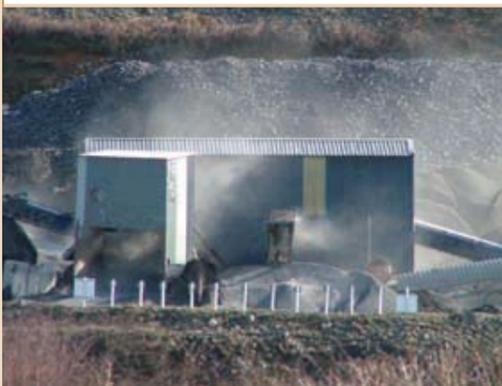
At Cribarth Quarry, crushed stone goes to a screen house for screening into different grades. The screen house uses a Finlay screen and a triple deck Parker screen which both produce a lot of dust. In the past, two people have shovelled this dust out of the screen house, but with the Workplace Exposure Limit (WEL) in place all contact with dust was required to be reduced.

- Clean water enters the Fogco;
- Water exits at very high pressure;
- The water passes through a micron filter;
- The water then passes through an ultraviolet lamp and radio frequency water softener; and
- Finally, the water passes through 65 nozzles set at 0.3 mm that atomise the water.

This process produces fog which fills the screen house as the dust particles rise. The fog clings to the dust particles and they fall through the cat-walk onto the ground where the dust can be cleaned out by a digger thereby removing the problem of high dust quantities settling on the floor.

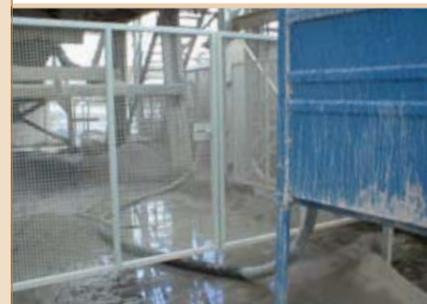
Several areas of the plant required regular cleaning which involved manually removing fine dust. It was decided to replace the manual tools with industrial vacuums to reduce the risk of dust inhalation.

A system of pipes was installed in relevant areas of the plant to allow an extraction unit to be used with a light pipe by the operator in a relatively dust free environment. This change has significantly reduced the risk of dust inhalation.

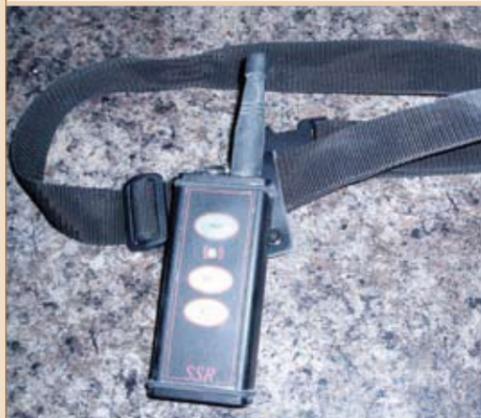
Three measures were taken to improve the safety of employees on site:

This is a device to aid a lone worker who may suffer an injury on site and require assistance. The device is carried by workers and when the alarm's button is held for five seconds it sends a signal to the plant office which triggers an alarm. If the alarm is not noted immediately the alarm starts to dial a series of pre-set phone numbers (of nominated employees) until someone answers. Whoever responds to the signal is informed of where the problem is and can deal with the situation accordingly.

This is a button that can also be found on the remote panic alarm and can be used to shut down the electrics on the plant if the worker is not near a site emergency stop button.

The device is about the size of a mobile phone and is attached to a holster worn by the employee. It is water proof and robust enough so it can't be damaged when working in challenging conditions. It has helped protect the workforce from several dangers.

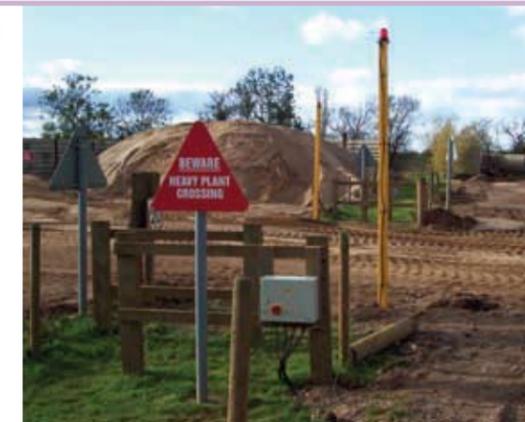
A public footpath existed at Besthorpe Quarry that passed through an area with mobile plant movements and posed a high risk. There was a concern that members of the public would not heed the danger when trying to cross at this point. So a traffic light system was installed to allow for safe crossing for pedestrians. The system is simple and safe and easily understood by both the public and the workforce.

The system works on a trigger system which is enabled when a pedestrian breaks the laser beam. The flashing lights are positioned on 2.5m poles to ensure they are clearly visible to mobile plant operatives. When the lights flash, all vehicles must stop allowing pedestrians to cross safely.

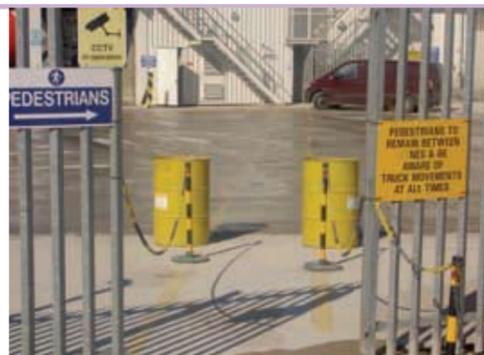
The high level of traffic movement at the site was causing congestion, leading to a greater chance of injuries to pedestrians. This is why there has been the introduction of pedestrian walkways to provide safe areas in the plant.

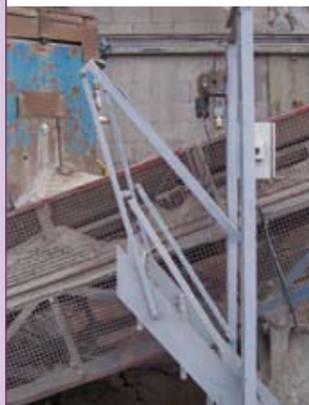
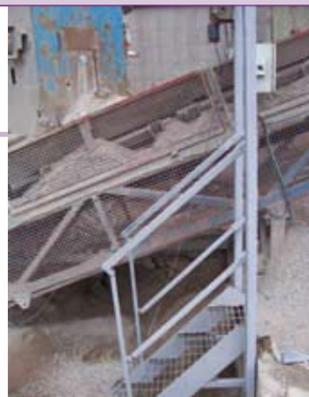
The tail end of the incline conveyor is situated in a concrete sump. A concrete ramp was used to access the conveyor to carry out any maintenance on the tail drum or to track the conveyor. These activities were hazardous in wet conditions, as the ramp could become unsafe to walk on, potentially leading to injury through a slip, trip or fall.

A set of steps needed to be fitted to make access and egress to the conveyer tail end safer. However, there was a further issue as access under the conveyer was required to clean up spillages and the steps would block this task.

The solution to this was to design a set of steps that could be moved into place for access and egress and moved away to facilitate cleaning, whilst at the same time avoiding manual handling. This was achieved by designing the steps to be foldable and controlled by an electrically powered winch. Raising and lowering the steps is achieved at the flick of a switch.

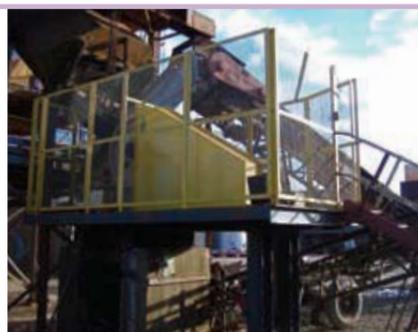
A new platform was designed that would give safe access and sufficient room to work safely. Manager-led discussions with the workforce led to recommendations on platform width, steps and handrail configurations.

The platform has been built internally and provides a safer way to work based on the ideas of the workforce.

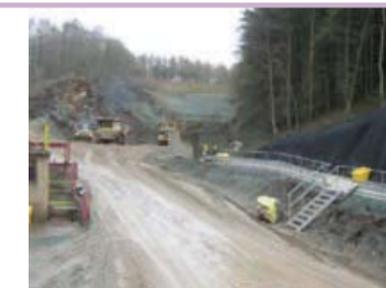
There are space constraints at this plant which create a danger for pedestrians as their paths cross that of mobile plant. The issue was resolved by the construction of a designated, elevated pedestrian walkway.

The walkway runs from the office block to a parking bay, large enough to accommodate the mobile plant fleet, creating a safer area for pedestrians.
