INCIDENT ALERT

LOCATION: ON-HIGHWAY
ACTIVITY: PRODUCTION AND PROCESSING
SUB ACTIVITY: ASPHALT & COATED STONE

Operative Struck by Roller

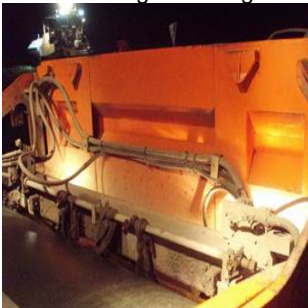
- The roller driver stated that at no time did he see the operative return to the area being rolled.
- The roller driver's visibility was severely impaired due to excessive amounts of steam generated during the rolling operation. This was due to the low temperatures and high humidity at the time.
- The existing front headlamps on the roller were not isolated when the grit box attachment was fitted to the roller. This resulted in lighting glare reflecting back into the roller cab further impairing the drivers vision.
- The operative was under the misapprehension that the roller driver was aware of his presence.
- The operative and the roller driver failed to adequately communicate with each other which resulted in neither of them knowing what the other was doing.

- Ensure all similar grit box rollers (Hamm HD90) are inspected to ensure that the front roller lights are either isolated or covered when the grit box attachment is fitted.

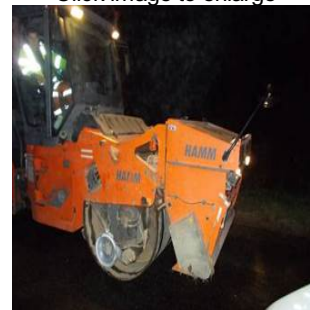
Front Lights Not Isolated

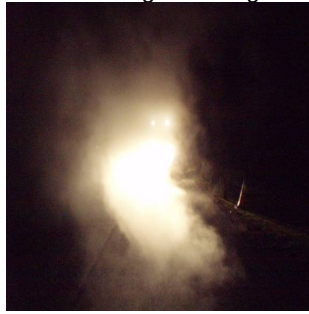
Steam reducing visibility

- Ensure that the Site Specific Risk Assessment (SSRA) and Job Briefing Sheet (JBS) adequately address weather and visibility issues during laying operations prior to work commencing.

- Ensure that the SSRA and JBS is revised and adequate control measures implemented where the weather unexpectedly deteriorates during the shift.
- Consider the cancellation / suspension of work (in discussion with client) where adverse weather is forecast and there is the potential for excessive steam to be generated, which may cause severe visibility restrictions for site personnel and/or the travelling public.
