INCIDENT ALERT

ALERT STATUS: Normal
DATE ISSUED: 14/04/2015 16:51:30
INCIDENT No: 01413

Articulated Dumper Truck Incident

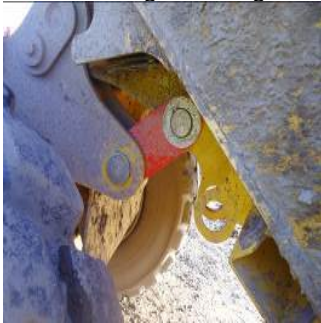
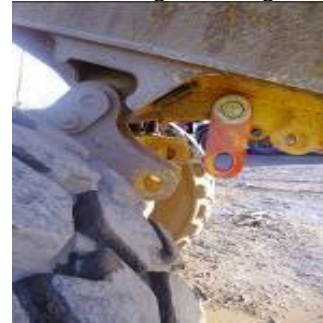
Whilst attempting to engage the locking mechanism the plant operator found that alignment could not be achieved and this prevented the insertion of the safety pin fully and asked a colleague to drop the skip slightly to try and align the holes.

The pressure from the movement of the skip caused the safety pin to eject with enough force to strike the plant operator's hand causing serious trauma. This has resulted in hospitalisation and the surgical amputation of his right hand middle finger.

- Review all plant provisions to ensure the safest equipment is in operation.
- Review all vehicles / plant maintenance operations and ensure they are being carried out correctly and all safety devices on any work equipment operate in accordance with the manufacturer's instructions.
- If the safety device does not function in accordance with the manufacturer's instructions, and prevents the plant / vehicle from working safely, park up your vehicle/plant and report it immediately to your supervisor.
- 'Do Not Use' signage must be visibly placed on the vehicle/plant and should also be locked where possible and keys returned to your supervisor pending repair to the safety device.
- Where the design of the vehicle is considered a contributory factor, ensure any findings are communicated through to the manufacturer / supplier for their continual improvement.
