Isolation lock out equipment near miss

LOCATION: AGGREGATE DREDGER
ACTIVITY: MAINTENANCE & HOUSEKEEPING
SUB ACTIVITY: N/A

ALERT STATUS: Normal
DATE ISSUED: 01/02/2016 12:49:05
INCIDENT No: 01425

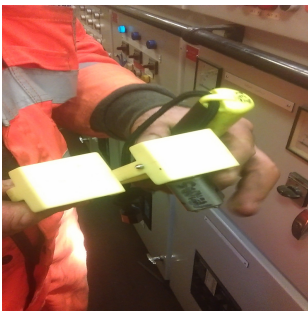
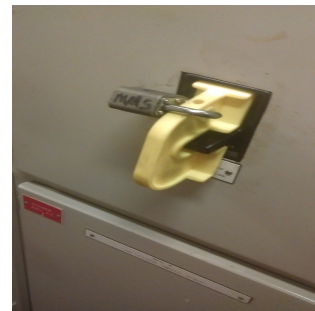
The equipment being isolated is switched on/off using a Bakelite switch, and the lockout equipment fits over the switch when it's in the off position. The equipment is fastened to the switch by a screw which grips switch and prevents the lockout from being removed. To prevent the screw being unscrewed a padlock is fitted which shields the screw head from a screw driver.

The lockout was fitted following procedure, however on inspection when the lockout equipment was touched and moved it slid off the

switch completely.

On investigation it transpires that because the switch is made of Bakelite which is hard and also brittle, it is not possible to screw the screw down on to the switch with sufficient purchase to gain enough grip to secure the lockout equipment in place.

A solution to this problem is currently under investigation.

Highlights the importance of testing and checking all aspects of the lock out process.

Highlights example of an unexpected problem when new elements introduced to lock out procedure.
