## Equipment mounted at height

This alert is issued following a previous alert regarding the failure of a drive motor and gearbox mounted at height.

**CONCRETE PRODUCTS PLANT**  
**MAINTENANCE & HOUSEKEEPING**  
**N/A**

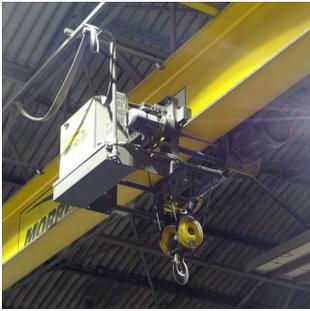
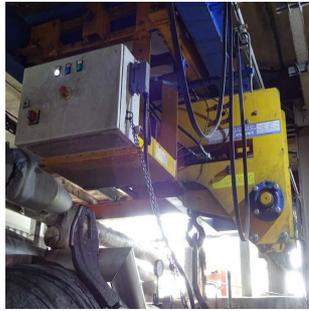
- Secondary securing devices prevent a component falling from height if the primary securing method fails. This could be a safety wire or some other engineered method designed for this function. Secondary securing devices should be sufficient to withstand the shock loading that may occur if the primary securing method fails.

- Ensure Planned Preventive Maintenance (PPM) is scheduled in line with manufacturer's recommendations as a minimum
- In harsher environments and high usage, more frequent inspection may be required.

- Ensure all materials used in the PPM or breakdown repairs meet with the manufacturer's specification, and any other technical standards that may apply.

- Where individual component parts require replacing consider the benefit of replacing the whole assembly to avoid the potential for backlash.
- Carry out assessments identifying areas where equipment is mounted / travels over people, consider fitting a secondary securing device.
