# Operator's leg fractured by spreader beam

<b>LOCATION:</b>	<b>CONCRETE PRODUCTS PLANT</b>	<b>ALERT STATUS:</b>	<b>Normal</b>
<b>ACTIVITY:</b>	<b>LIFTING</b>	<b>DATE ISSUED:</b>	<b>24/10/2016 11:04:31</b>
<b>SUB ACTIVITY:</b>	<b>NO SUB ACTIVITY AVAILABLE</b>	<b>INCIDENT No:</b>	<b>01443</b>

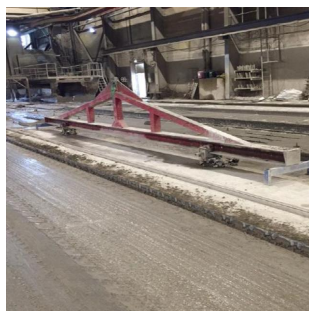
An accident at a factory producing hollow core slabs was caused by the lifting chains fitted to the underside of spreader beam making the beam unstable – see image.

The IP (Injured person), a trained overhead crane operator, was moving a spreader beam from one location to another to allow the floor to be cleaned. The spreader beam was attached to an overhead crane and as the IP set the spreader beam onto the ground it became unstable. The beam had been resting on the chains on the underside of the beam. Once the IP released the crane from the spreader beam, it fell over and fractured his leg.

Chains on spreader beam

- Stabilisers have now been fixed to this and other spreader beams that have the potential to fall over.
- Risk assessments and safe systems of work have been reviewed, updated and communicated

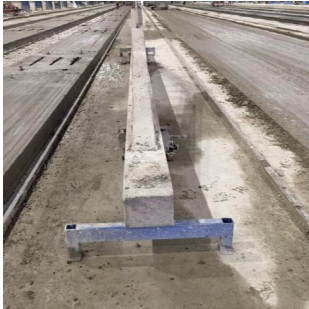
Spreader beam with stabiliser
