## INCIDENT ALERT

**LOCATION:** QUARRY  
**ACTIVITY:** PRODUCTION AND PROCESSING  
**SUB ACTIVITY:** FACE ACTIVITY

**ALERT STATUS:** Normal  
**DATE ISSUED:** 14/03/2017 15:11:59  
**INCIDENT No:** 01448

**Serious Drill Rig Incident**

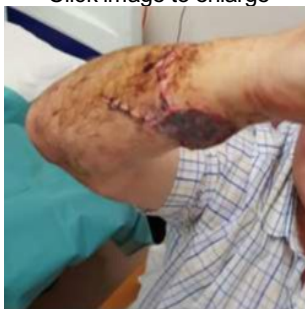
A Drill Rig operative sustained a broken lower right arm as a result of entrapment on a drill rod carousel while changing a sensor.

The initial investigation has identified that the safety sensor (pad) in the seat of the drill rig had been disconnected allowing the operator to leave his seat in the cab and work on the drill carousel without appropriate isolation.

**Injured Arm**

All site drilling activities were suspended.

Remove the drill rig from all operational activities.

Inspect all other drill rigs to confirm seat safety sensor (pad) is in place and functional.

Review and update Drill Rig pre-start checks to include the seat safety sensor (pad) is in place and functional.

Issue an instruction to confirm: NO maintenance is to be carried out on drill rigs by Drill Rig operatives. Note: All maintenance activities MUST only be carried out by trained authorized maintenance teams.
