## INCIDENT ALERT

**01462**

**Driver Saved by Seatbelt**

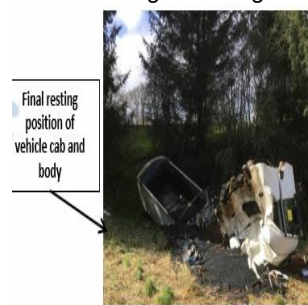
The vehicle exited over a grass verge and became embedded in the soft ground below, with the cab detaching from the vehicle body and rolling several times, before coming to rest about 15 feet away, with the driver left suspended by his seatbelt.

Final resting position of vehicle cab and body

- Providing defensive driving training and monitoring driving styles
- By driving at an appropriate speed for the road conditions
