INCIDENT ALERT

Tyre rim wear

Inspection of wheel rims at tyre change

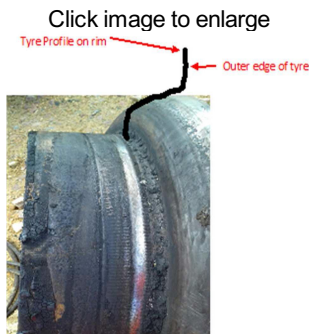
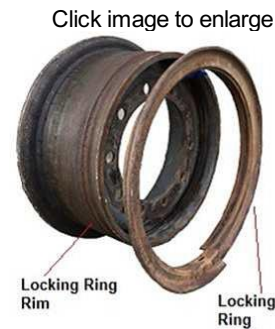
The result of the investigations found that the rim was worn causing air to escape and the tyre to be under inflated. The resulting damage, which provided insufficient grip to the tyre and under inflation, allowed the tyre to move on the rim creating heat that lead to the blow out.

The image shows a silver band on the rim that has been caused by the tyre moving on the rim. The area should be a serated band to help grip the tyre

Silver band on rim

- Any unexpected loss of tyre pressure during regular checks should be reported.
- Ensure tyre companies inspect the rims for damage when fitting new tyres.
- Tyre blow-outs can be fatal and all repairs must be carried out by a competent company.
