# INCIDENT ALERT

**LOCATION:** CONCRETE PRODUCTS PLANT  
**ACTIVITY:** GUARDING AND ISOLATION  
**SUB ACTIVITY:** NO SUB ACTIVITY AVAILABLE

**Failure of wire after stressing**

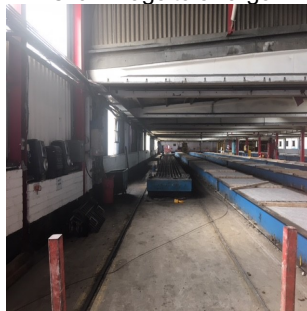
During a routine stressing procedure using 5 mm wire for the production of wet cast T-beams, a wire snapped in the centre of the bed seconds after the bed had been stressed and the pins inserted, causing an unplanned release.

The two broken parts traversed to either end of the bed travelling underneath the restraining chains, exited the end of the bed and continued to travel some distance down the workshop.

The wire was quarantined and both ends of the broken wire sent away for independent metallurgical examination. The conclusion was that the wire had been welded resulting in decarburisation.

- Not to rely totally on the restraining chains.
- An enhanced exclusion process with a time factor built-in during and immediately following the stressing process, has been implemented.
- Additional guarding at the live end and safe, guarded zones for the operative undertaking the stressing process have been introduced.
- Ensuring that the wire conforms to the British Standard.
