INCIDENT ALERT

LOCATION:	QUARRY	ALERT STATUS:	Normal
ACTIVITY:	TRANSPORT / DELIVERY	DATE ISSUED:	07/09/2018 15:10:16
SUB ACTIVITY:	MOBILE PLANT	INCIDENT No:	01495

Failing to wear a seatbelt whilst operating mobile plant

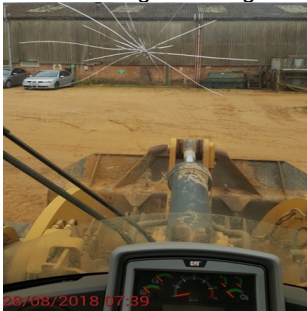
A front loading shovel driver was banging out a bucket whilst travelling up a ramp. As the bucket tipped forward it dug into the ramp causing the loading shovel to stop suddenly. The sudden stop caused the driver to be flung forwards. However, as he was not wearing a seatbelt, his momentum was not checked and his head hit the windscreen.

A review of the incident established that to override the seatbelt safety system, the seatbelt had been placed in the clip and the seatbelt placed behind the driver.

Crack on windscreen caused by impact with head

- Seatbelts are part of the overall safety system for a mobile plant to protect people from harm if the vehicle stops suddenly or overturns
- Seatbelts only work if they are worn correctly
- It is against the law for anyone to interfere or misuse anything provided in the interest of health and safety

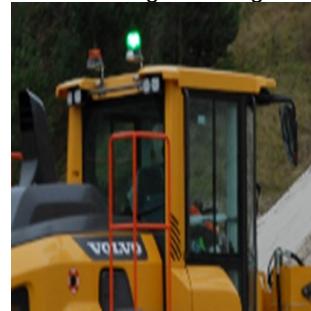
Green light on cab to indicate seatbelt is being worn
