# Failing to wear a seatbelt whilst operating mobile plant

**Not wearing a seatbelt on mobile plant caused driver's head to hit windscreen.**

LOCATION: QUARRY  
ACTIVITY: TRANSPORT & LOGISTICS / DELIVERY  
SUB ACTIVITY: MOBILE PLANT

ALERT STATUS: Normal  
DATE ISSUED: 07/09/2018 15:10:16  
INCIDENT No: 01495

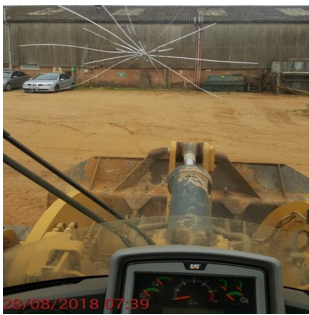
A front loading shovel driver was banging out a bucket whilst travelling up a ramp. As the bucket tipped forward it dug into the ramp causing the loading shovel to stop suddenly. The sudden stop caused the driver to be flung forwards. However, as he was not wearing a seatbelt, his momentum was not checked and his head hit the windscreen.

Crack on windscreen caused by impact with head

- Seatbelts are part of the overall safety system for a mobile plant to protect people from harm if the vehicle stops suddenly or overturns
- Seatbelts only work if they are worn correctly
- It is against the law for anyone to interfere or misuse anything provided in the interest of health and safety

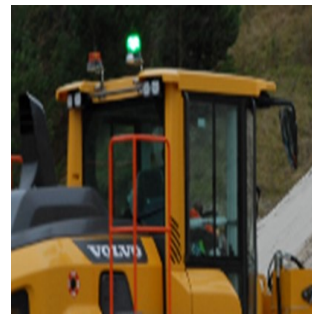
A review of the incident established that to override the seatbelt safety system, the seatbelt had been placed in the clip and the seatbelt placed behind the driver.

Green light on cab to indicate seatbelt is being worn
