## Fatal 6 – Employee enters hopper without PTW or Isolating

LOCATION: CONCRETE PRODUCTS PLANT  
ACTIVITY: MAINTENANCE & HOUSEKEEPING  
SUB ACTIVITY: N/A

ALERT STATUS: Normal  
DATE ISSUED: 19/03/2019 13:00:36  
INCIDENT No: 01509

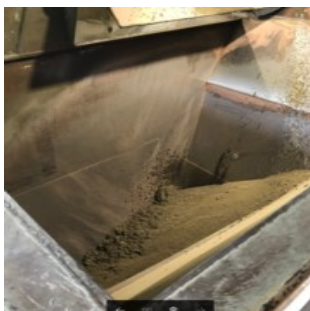
An employee entered a hopper below the mixer to start clearing out material that was going hard due to a conveyor belt failure underneath, without following the correct site procedures.

The mixer hopper is classed as an enclosed space and therefore no entry to this area is allowed without isolating the press conveyor belt and also being issued with a Permit to Work.

Hopper the employee entered

- The employees should have followed the essential safety procedures, rather than allow their urgency to leave site for personal reasons to affect their behaviour.
- The second observing employee could have stepped in to prevent his colleague entering the hopper without a permit to work.

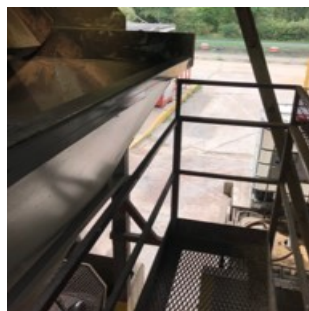
A second employee who was fully aware that a Permit to Work had not been issued, stood on the adjacent platform and watched his colleague enter the hopper without stepping in to stop him.

Access platform from which other employee observed
