Fatal 6 – Employee enters hopper without PTW or Isolating

LOCATION: CONCRETE PRODUCTS PLANT
ACTIVITY: MAINTENANCE & HOUSEKEEPING
SUB ACTIVITY: N/A

ALERT STATUS: Normal
DATE ISSUED: 19/03/2019 13:00:36
INCIDENT No: 01509

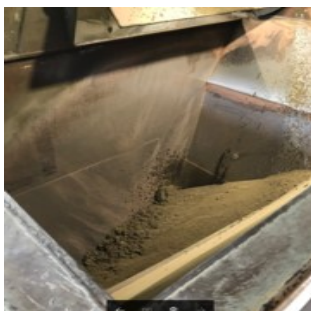
An employee entered a hopper below the mixer to start clearing out material that was going hard due to a conveyor belt failure underneath, without following the correct site procedures.

The mixer hopper is classed as an enclosed space and therefore no entry to this area is allowed without isolating the press conveyor belt and also being issued with a Permit to Work.

Hopper the employee entered

- The employees should have followed the essential safety procedures, rather than allow their urgency to leave site for personal reasons to affect their behaviour.
- The second observing employee could have stepped in to prevent his colleague entering the hopper without a permit to work.

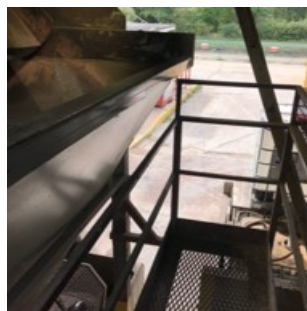
A second employee who was fully aware that a Permit to Work had not been issued, stood on the adjacent platform and watched his colleague enter the hopper without stepping in to stop him.

Access platform from which other employee observed
