INCIDENT ALERT

LOCATION:	CONCRETE PRODUCTS PLANT	ALERT STATUS:	Normal
ACTIVITY:	MAINTENANCE & HOUSEKEEPING	DATE ISSUED:	19/03/2019 13:00:36
SUB ACTIVITY:	N/A	INCIDENT No:	01509

Fatal 6 – Employee enters hopper without PTW or Isolating

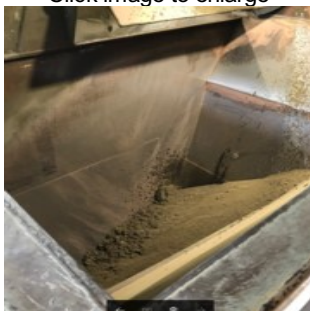
An employee entered a hopper below the mixer to start clearing out material that was going hard due to a conveyor belt failure underneath, without following the correct site procedures.

The mixer hopper is classed as an enclosed space and therefore no entry to this area is allowed without isolating the press conveyor belt and also being issued with a Permit to Work.

Hopper the employee entered

- The employees should have followed the essential safety procedures, rather than allow their urgency to leave site for personal reasons to affect their behaviour.
- The second observing employee could have stepped in to prevent his colleague entering the hopper without a permit to work.

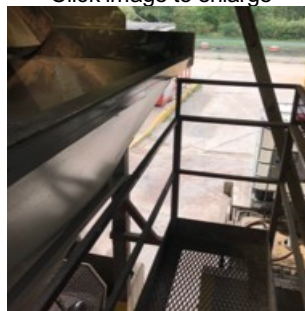
A second employee who was fully aware that a Permit to Work had not been issued, stood on the adjacent platform and watched his colleague enter the hopper without stepping in to stop him.

Access platform from which other employee observed
