# INCIDENT ALERT

LOCATION: CONCRETE PRODUCTS PLANT  
ACTIVITY: MAINTENANCE & HOUSEKEEPING  
SUB ACTIVITY: N/A

Fatal 6 - Faulty isolator switch

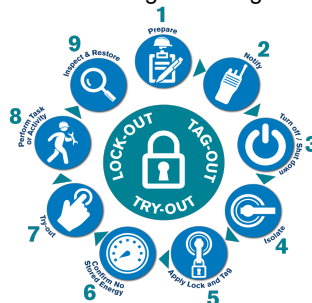
Whilst undertaking a maintenance task on a piece of plant, it was observed that the isolator switch worked correctly and the LOTOTO process was a success. The lock was applied and the machine was tried out successfully. When attempting to remove the lock after the task, it was noticed that, with the lock still in place, the isolator switch could still turn back to the ON position with slight resistance.

An investigation showed that the isolator switch locking mechanism (in blue circle below) was damaged internally, but external visual checks showed that it was in full working order.

- Include an isolator function check on the pre-start check sheets.
- When locking out check the isolator does not turn back.
