Fatal 6 - Return roller nip guard on conveyor falls 4m and hits contractor

LOCATION: QUARRY
ACTIVITY: MAINTENANCE & HOUSEKEEPING
SUB ACTIVITY: N/A

ALERT STATUS: Normal
DATE ISSUED: 28/05/2019 12:02:48
INCIDENT No: 01512

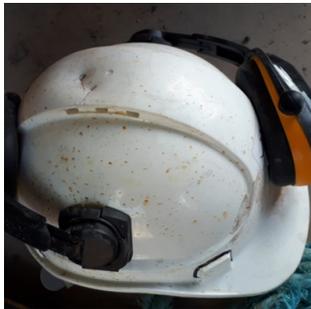
The contractor was standing under the incline conveyor belt system as he pulled the old conveyor belt through the system. During this operation an original return roller nip guard was dislodged. Investigation showed that it was designed so that it hung over the roller shaft and was only held in place by the belt and gravity.

The guard weighing circa 8kg fell 4m and hit the contractor on the centre of his hard hat. Fortunately, the contractor suffered only neck and muscle strain and was able to continue working after a short period.

- Check to see if this type of system is present on your site
- If they are on site, amend risk assessments / safe systems of work to include the need to check how roller nip guards, rollers and scrapers are secured
- Ensure all return roller nip guards, rollers and scrapers are securely fixed before any conveyor belt replacement work commences
- Any person carrying out a task where objects or items above them could fall should wear a hard hat, not a bump hat.
- Exclusion zones should be set up in any area where equipment is being worked on overhead
