INCIDENT ALERT

LOCATION:	CONTRACTING - ON-HIGHWAY	ALERT STATUS:	Normal
ACTIVITY:	PUBLIC SAFETY MANAGEMENT	DATE ISSUED:	16/08/2019 16:45:23
SUB ACTIVITY:	NO SUB ACTIVITY AVAILABLE	INCIDENT No:	01526

Flailing operation on hedgerow puts public at risk - near miss

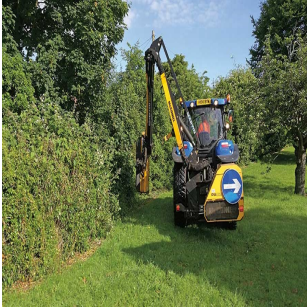
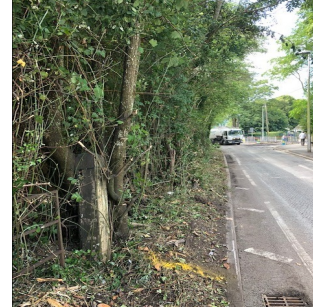
During recent operations by a road surfacing team, part of the work involved cutting back a hedgerow prior to the road surfacing operations. A tractor and flail was used for this operation, the activity resulted in a near miss incident. The hedgerow was 4m thick and the subcontractor undertaking the task was experienced in this type of work. Pedestrians were diverted away from the side of the hedge being cut back. However, despite the completion of a risk assessment, the full impact of the flailing action of the machinery involved had not been considered. There had been insufficient communication with the residential properties on the opposite side of the hedge. It was not foreseen that the operations would affect them. Debris from the flailing exercise travelled through the hedgerow and landed around the property of a resident. No people were harmed but it was by chance that nobody was present when the tractor and flail passed by.

- Technical performance specifications for any machinery used on site must be incorporated into the risk assessment process.
- Prior to commencement of works on a site, all types of machinery must have been considered within the RAMS document.
- The potential impact on members of the public and surrounding property at every step of the process must be considered.

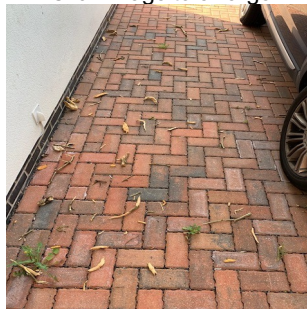
Debris in drive
