INCIDENT ALERT

LOCATION: ASPHALT/COATING PLANT
ACTIVITY: MAINTENANCE & HOUSEKEEPING
SUB ACTIVITY: N/A

ALERT STATUS: Normal
DATE ISSUED: 25/11/2019 10:06:02
INCIDENT No: 01536

Fatal 6 - Bitumen spill due to faulty butterfly valve

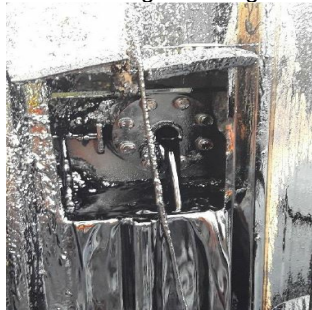
An external fitter was attempting to replace a pressure sensor probe which was situated at the bottom of a vertical bitumen tank. He removed the cover plate to gain access to the butterfly isolation valve, due to the valve handle being missing he used mole grips to turn the butterfly valve 90 degrees. He assumed because he had turned the valve until it stopped, that the valve was fully closed. This was not the case. He then loosened the damaged pressure sensor with a large adjustable spanner and started to remove it by hand. The sensor probe was easily removed but the bitumen started pouring out of behind the sensor and by then it was too late to put it back in as the butterfly valve was obviously open instead of shut. The fitter was wearing welder's gauntlets and a fireproof boiler suit but a small amount of bitumen trickled down the boiler suit into the gauntlet causing a burn covering the back of the left hand. The investigation highlighted that the butterfly valves are not suitable as there is no way of positively identifying what position the valve is in. The manufacturer is now fitting gate valves as standard instead of butterfly valves to prevent this issue.

Butterfly Valve with Sensor Probe removed

Gate valves utilise a movable gate or door to allow or prevent flow. In most cases the gate is raised or lowered using a mechanical assist of some kind – often a threaded screw. Flow is initiated by lifting the gate and prevented by lowering the gate. The following action is being taken: - All bitumen tanks to be investigated to determine which type of valve is fitted. - Butterfly valves are to be replaced with gate valves during the next pressure sensor change by a trained and competent person. - This work should only be carried out after the bitumen tank is either empty or completely cooled to reduce the risk of this incident happening again.

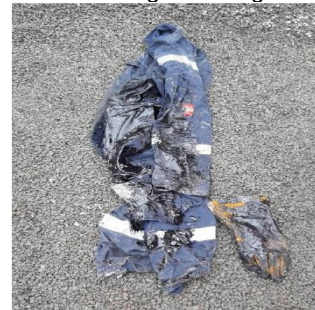
Bitumen covered PPE
