INCIDENT ALERT

02565

Contractor Severs Fingers on Conveyor Belt

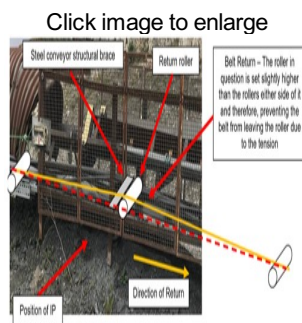
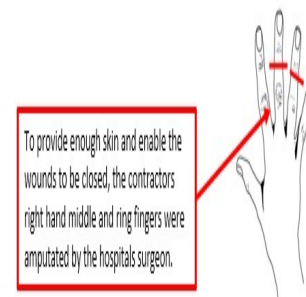
One of the contractors notice a flapper (small strip of belting) hanging from the edge of the belt as it was running. The contractor knelt down and reached underneath the guard grabbing the flapper, believing that it would snap off. Instead it pulled his hand over a return roller with the belt trapping it. As he pulled his hand back the 3rd & 4th fingers of his right hand were degloved to the first knuckle.

- Original task was completed according to procedures including isolation, Risk Assessment and Method Statement and Worksafe.
- The Safety Inspections, VFL's and training reports were all up to date.
- Emergency response plan was followed.
- The roller was set slightly higher than the two either side of it, causing additional tension on the belt so it could not lift from the roller.
- Due to the above, to meet British Standards, the guard should have been slightly larger; however this would not have prevented the injury.
- The contractor had worked on the site for 10 years.

- Guarding fully extended to the ground.
- Follow site rules and never attempt to touch a piece of moving equipment.

- Are return rollers inspected, checking that the belt can easily yield 50mm from the roller?
- Where the belt cannot yield 50mm from the roller, is there sufficient guarding in place to ensure that the trapping point cannot be reached?
- Is there a Safe System of Work for conveyor belt maintenance and removal of flappers and are they communicated to the workforce?
- Have employees received the STOP-THINK-ACT training helping them to identify hazards, and keep out of the line of fire?
- Is everyone encouraged to STEP IN if they see any unsafe acts on our sites?
